KEFALONIA EARTHQUAKE 26/1/2014 AND 3/2/2014

Technical Report · May 2014

STRONG GROUND MOTION OF THE FEBRUARY 3, 2014 (M6.0) CEPHALONIA EARTHQUAKE: EFFECTS ON SOIL AND BUILT ENVIRONMENT IN COMBINATION WITH THE JANUARY 26, 2014 (M6.1) EVENT

**T H E S S A L O N I K I
F E B R U A R Y 2 0 1 4**

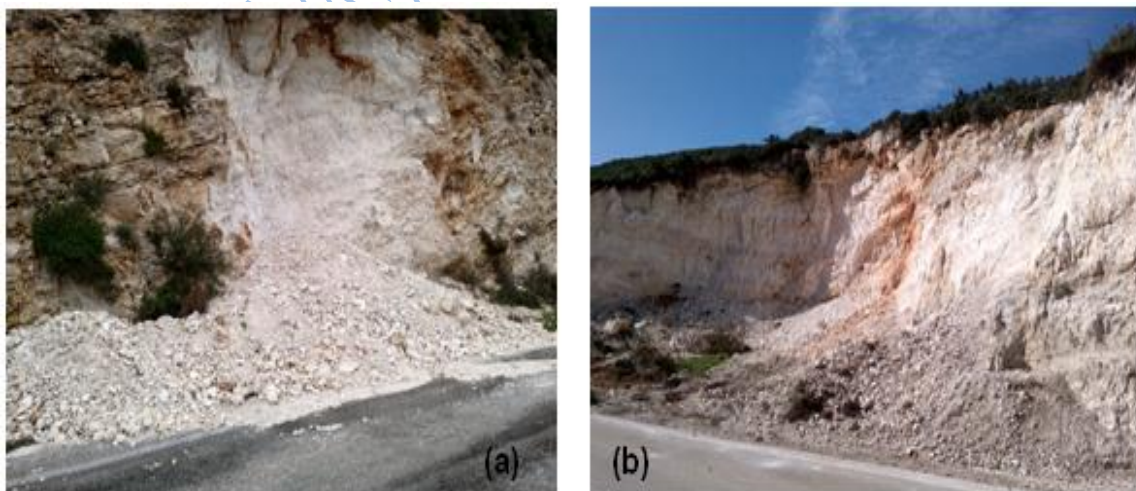
Figure 2.6. Rock slides in cracked limestone formations recorded at the northern part of Argostoli bay (38.287065° N, 20.448024° E) following (a) the first strong earthquake of 26/01/2014 and (b) the second strong earthquake of 03/02/2014

20.410148° E to 38.160405° N, 20.413083° E) south of Paliki peninsula (Figure 2.5). Rock slides in cracked limestone formations were also recorded at the northern part of Argostoli bay (38.287065° N, 20.448024° E). Evidently, the second earthquake contributed further to the evolution of the above rock slide as shown in Figure 2.6. Substantial rock slope failures were recorded in Myrtos Bay. On the east slope, two limestone blocks rolled down causing total damage to the road (38.337833°N, 20.532317°E). The above roll path is depicted in Figure 2.7.

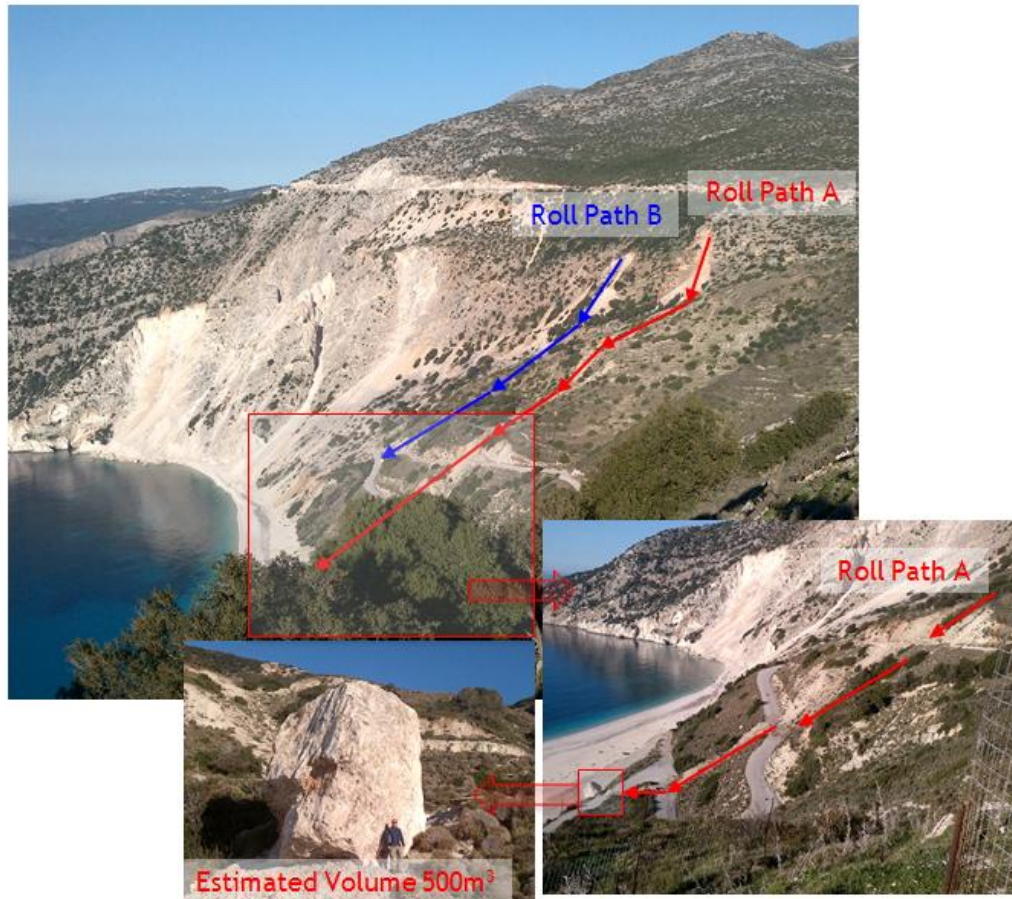
Figure 2.7. Roll path of two limestone blocks recorded at Myrtos Bay after the first earthquake inducing total damage to the descending road (38.337833° N, 20.532317° E).

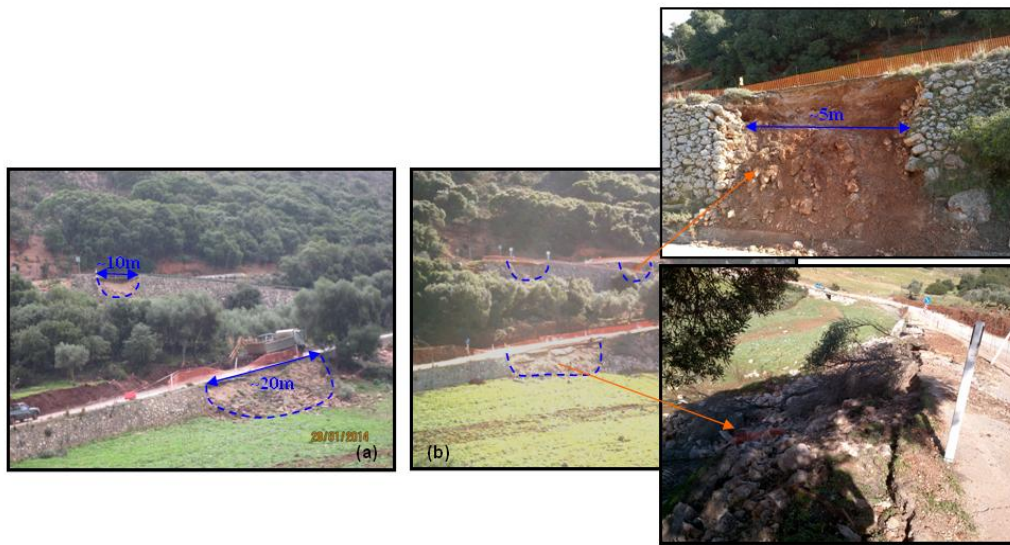
A major failure of a long stone masonry retaining wall was observed along the road network (38.293224° N, 20.45217° E) leading to Atheras village north of Paliki peninsula. Out-of-plane collapse was recorded in two successive points after the first strong earthquake of 26/01/2014 having an estimated failure length of 10m and 20m respectively (Figure 2.8a). The above failures were further deployed after the second strong earthquake of 03/02/2014 imposing an additional failure surface at a third location (Figure 2.8b).

Figure 2.8. (a) Extensive failure of a stone masonry retaining wall followed by road embankment settlement close to Atheras Village (38.293224° N, 20.45217° E) after the first earthquake of 26/01/2014. (b) Additional failure surface at a third location of the wall induced by the second strong earthquake of 03/02/2014.

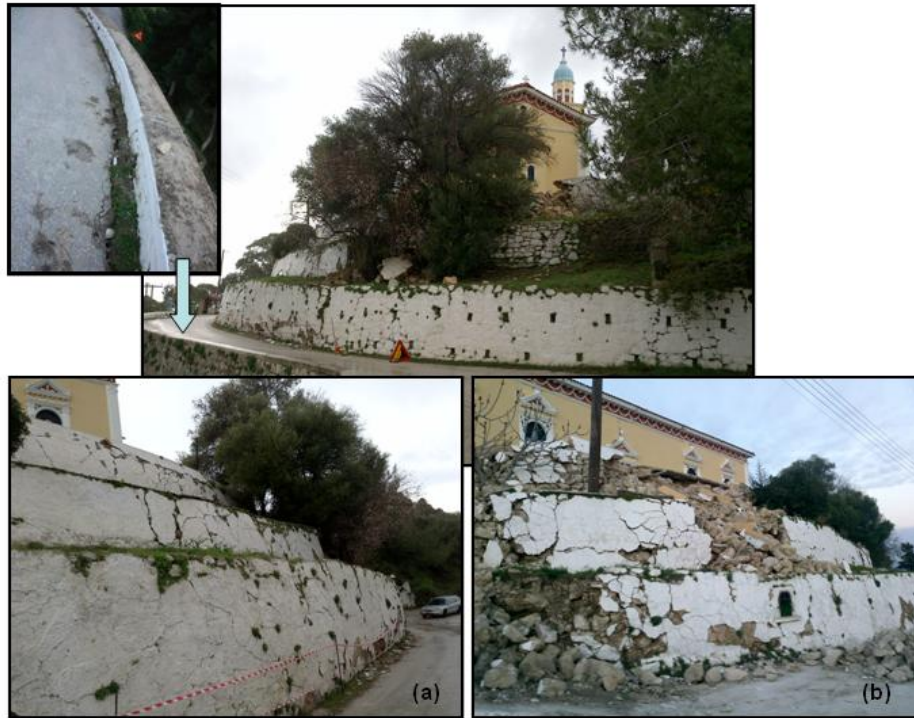
Particularly extensive cracks were observed at a 5m high stone masonry retaining wall supporting the foundation soil of a church in Chavriata village (38.182677° N, 20.387261° E), following the first strong earthquake on 01/26/2014 (Figure 2.9a). The evident disruption and loss of connection between the stones should have minimized the lateral strength of the wall mobilizing a total collapse and subsequent debris fall of the supporting ground after the second earthquake of 03/02/2014 (Figure 2.9b). On the contrary, the underlying stone masonry retaining wall supporting the road embankment (shown by an arrow in Figure 2.9) was slightly displaced (by approximately 5cm) from his original position without any visible failures.

Figure 2.9. Major failure of a three-level stone masonry retaining wall supporting the foundation soil of a church in Chavriata village (38.182677° N, 20.387261° E): (a) Extensive cracks observed following the first earthquake of 26/01/2014 (b) total collapse of the wall following the second strong earthquake of 03/02/2014.

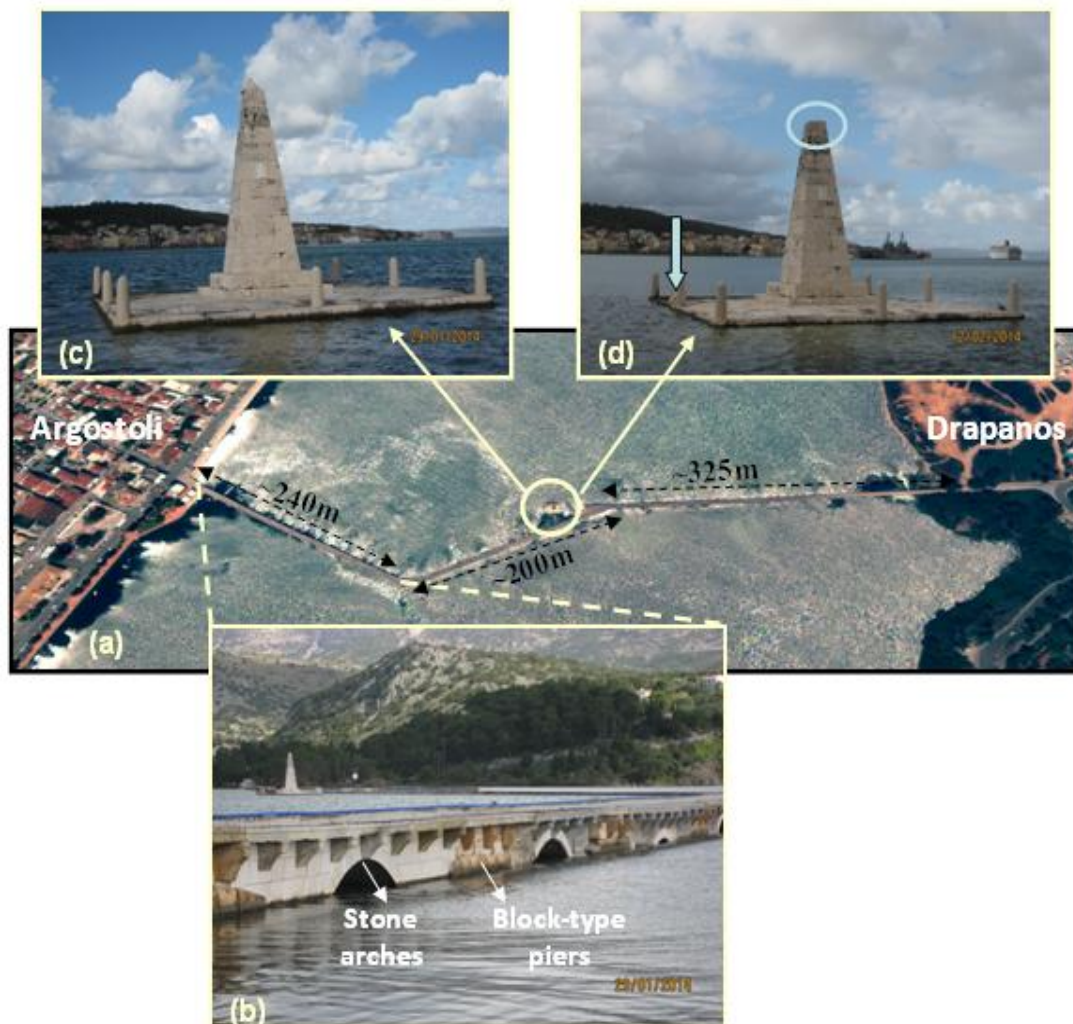
Figure 2.11. (a) De Bosset bridge ($38^{\circ}10'26.25''N$, $20^{\circ}29'45.59''E$), (b) Rehabilitated bridge with no damage recorded after the two major earthquakes of 26/01/2014 and 03/02/2014, (c) Multi-drum column monument remained intact after the first earthquake and (d) Toppling of the upper drum of the column monument induced by the second earthquake.

The rehabilitated “De Bosset” bridge inspected after the two major earthquakes of 26/01/2014 and 03/02/2014 and revealed no damage or visible defects on the bridge indicating a very satisfactory seismic performance, despite the high accelerations induced by these major earthquakes. Apparently, the rehabilitation measures should have contributed to the observed seismic behavior of the bridge. The only visible effect of the earthquake sequence was recorded at a 10m multi drum limestone column monument located very close to the middle part of the bridge (Figure 2.11c), where the upper drum toppled down after the second earthquake of 03/02/2014 (Figure 2.11d).

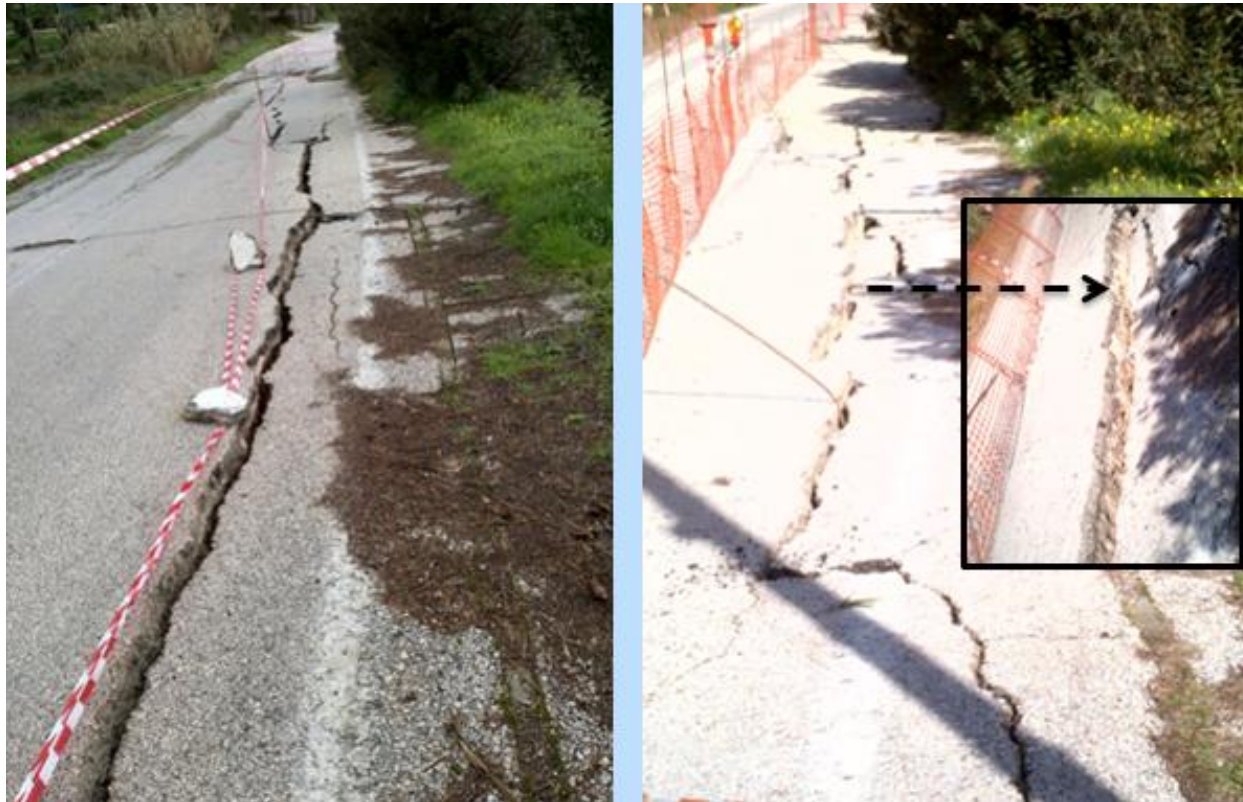
A similar but less extensive evolution of road cracking after the second earthquake due to the settlement of the underlying embankment was recorded at the road network between Agios Dimitrios and Livadi villages (Figure 2.13). In this case, the settlement of the embankment was measured at 20cm approximately.

Figure 2.13. Cracks and embankment settlement recorded at the road network between Agios Dimitrios and Livadi villages ($38.238103^{\circ}\text{N}$, $20.428973^{\circ}\text{E}$) induced by the first (left) and the second (right) earthquake.

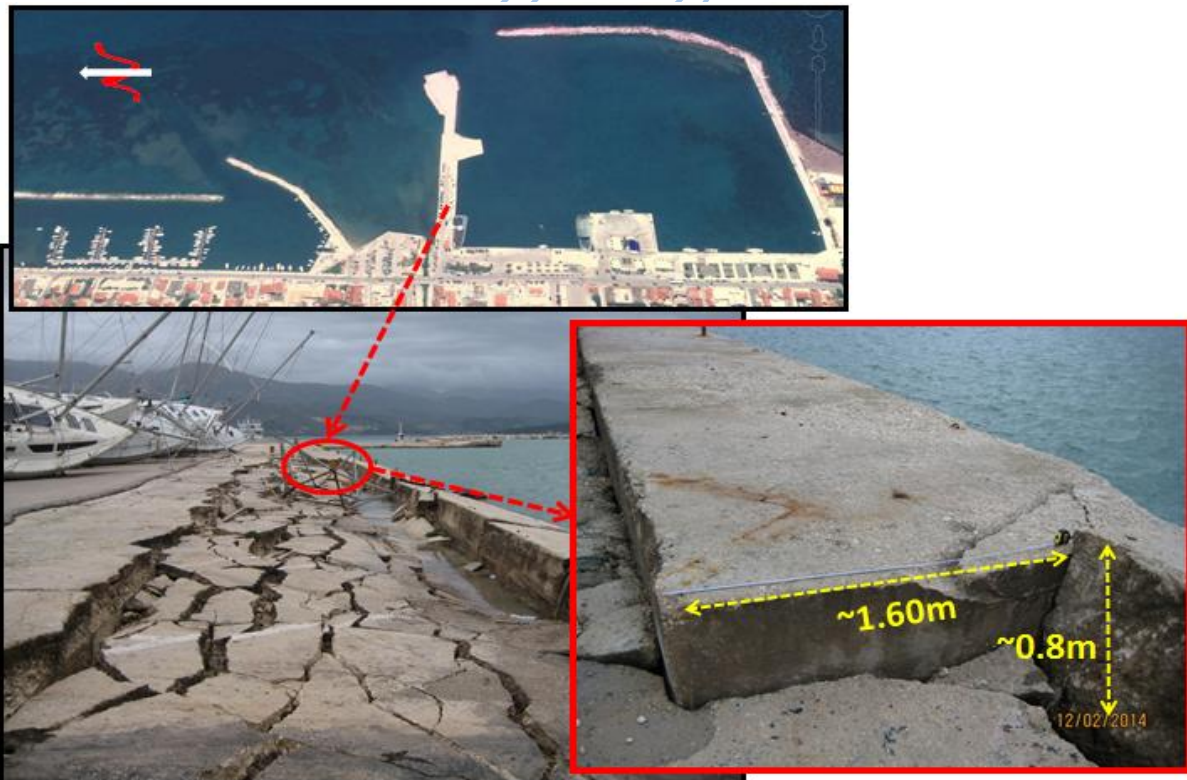
The second earthquake of 03/02/2014 induced severe failures at the port of Lixouri including important horizontal displacements and rotations of the quay walls, extensive cracks on the port jetties and major liquefaction *ejecta* followed by lateral spreading. The above type of failures was repeatedly observed along the 950m long main piers of Lixouri port (Figure 2.14). The severity of the induced failures is evident in Figure 2.15 showing the magnitude of relative displacement between two adjacent quay walls and settlement of the backfill recorded at the same point along the south part of the 250m main pier of Lixouri port due to lateral spreading. Interestingly, the north side of the same pier (shown in Figure 2.14 with a blue dashed line) remained practically intact after the second earthquake. A similar deformation pattern was observed at the old jetty of the above pier (Figure 2.16). The recorded displacement of the quay walls were recorded as high as 80cm.

Figure 2.15. Extensive lateral spreading and quay walls deformation induced by the second earthquake on the 250m main pier of Lixouri port.

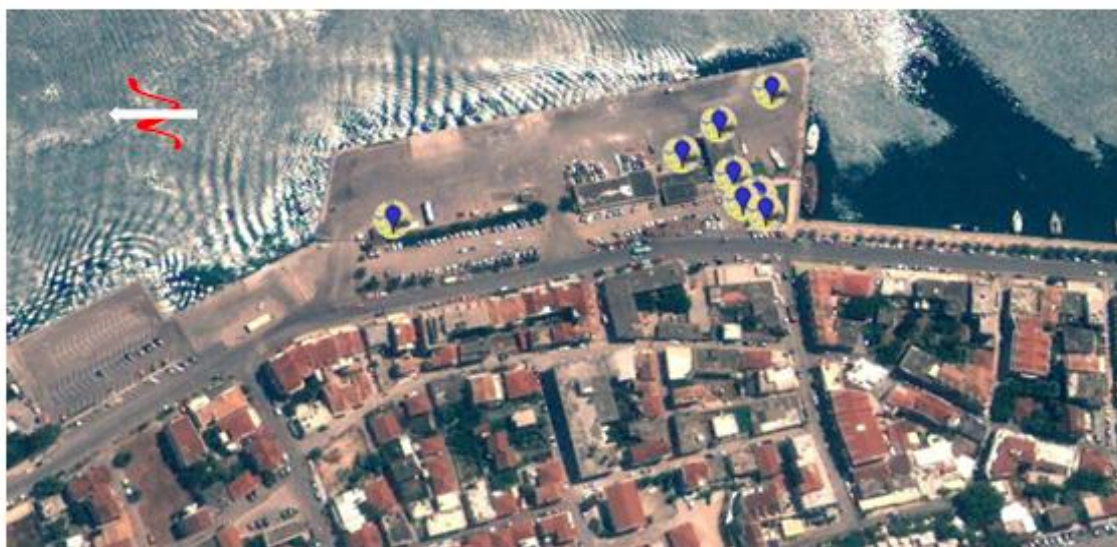
Compared to Lixouri port, substantial but less extensive liquefaction phenomena were also recorded in the port of Argostoli. The corresponding distribution of liquefaction traces along Argostoli port as recorded after the second earthquake is given in Figure 2.21. A representative case showing the effect of the second earthquake on the quay walls of

Figure 2.21. General outline of liquefaction traces recorded after the second earthquake along Argostoli port.

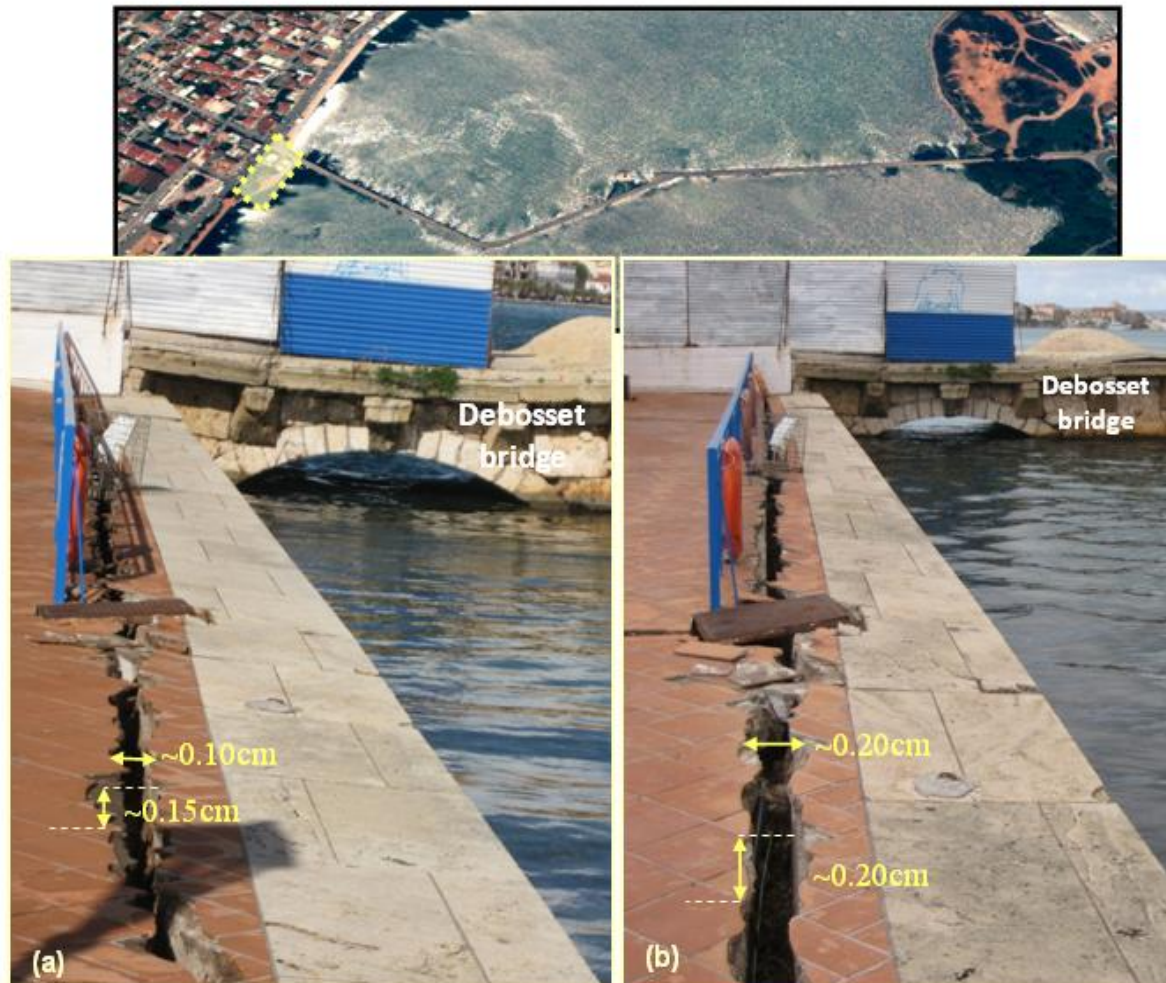
Argostoli port was recorded at a location close to De Bosset bridge. The adjacent quay wall suffered permanent horizontal displacement of 10cm towards the shoreline whereas backfill settlement was measured at 15cm approximately due to the first earthquake of 01/26/2014 (Figure 2.22a). The observed lateral movement of the quay wall and settlement of the backfill were further increased (almost doubled in some points) after the second earthquake (Figure 2.22b).

Figure 2.22. Observed failures of the quay wall adjacent to the Debossset bridge: permanent lateral displacement of the quay wall and settlement of the backfill induced by (a) the first earthquake of 01/26/2014 and (b) the second earthquake of 03/02/2014.

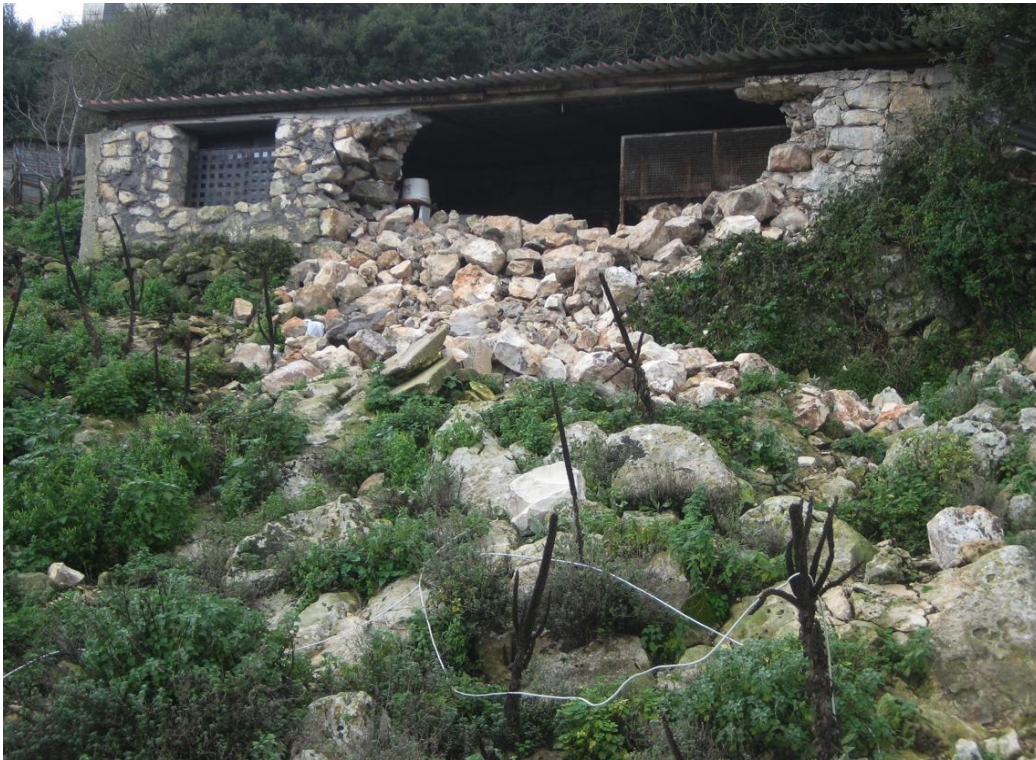
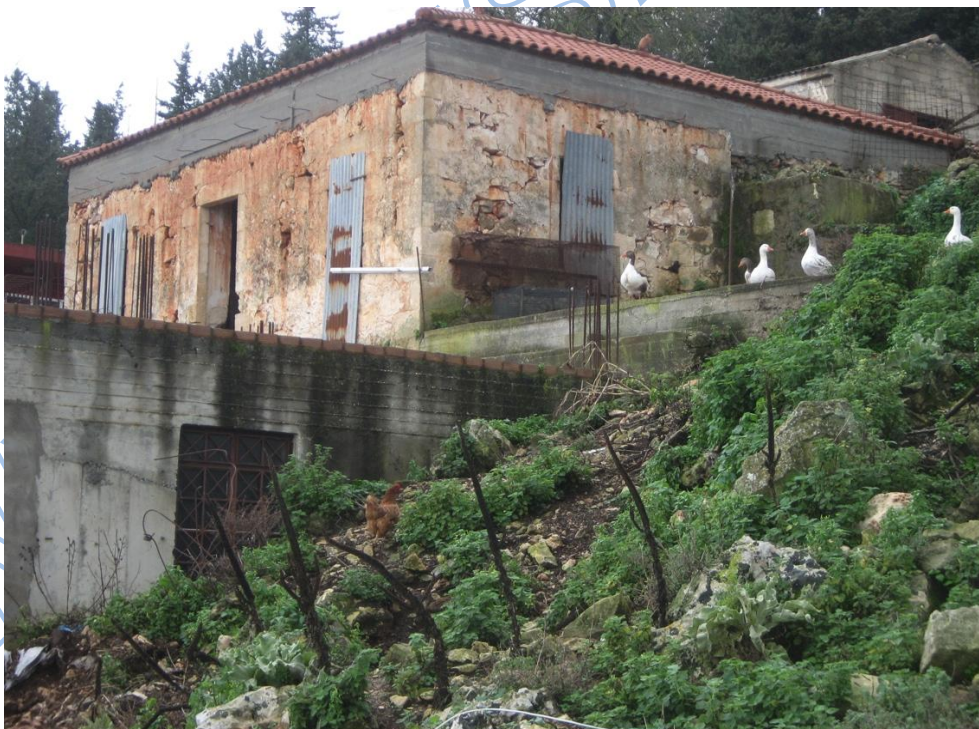
Photos 3.1, 3.2. Two neighbor masonry buildings at the villages. The building with strong R/C ties at top had no damage.

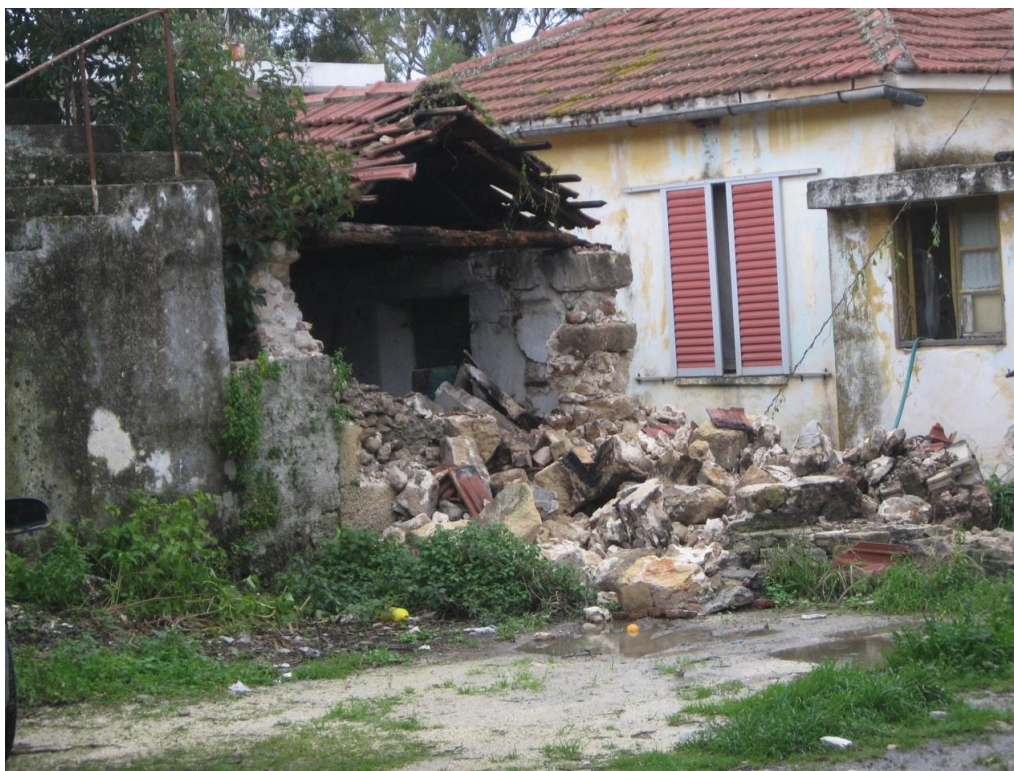
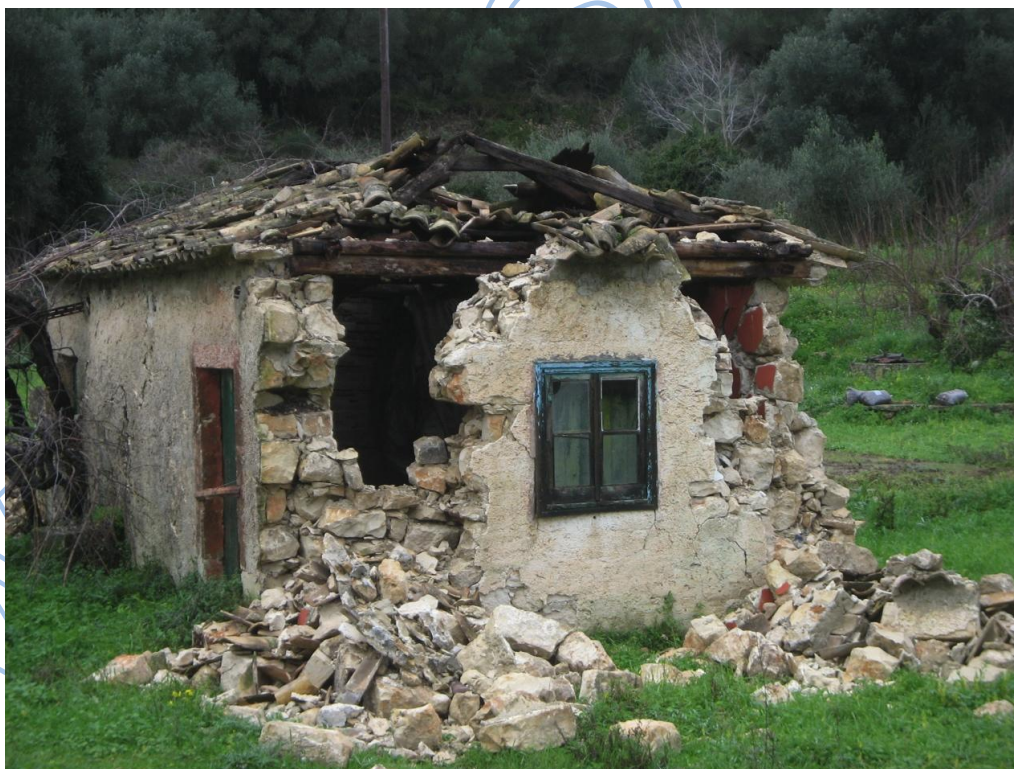
Photos 3.3, 3.4. Partial collapses of masonry buildings of secondary use.

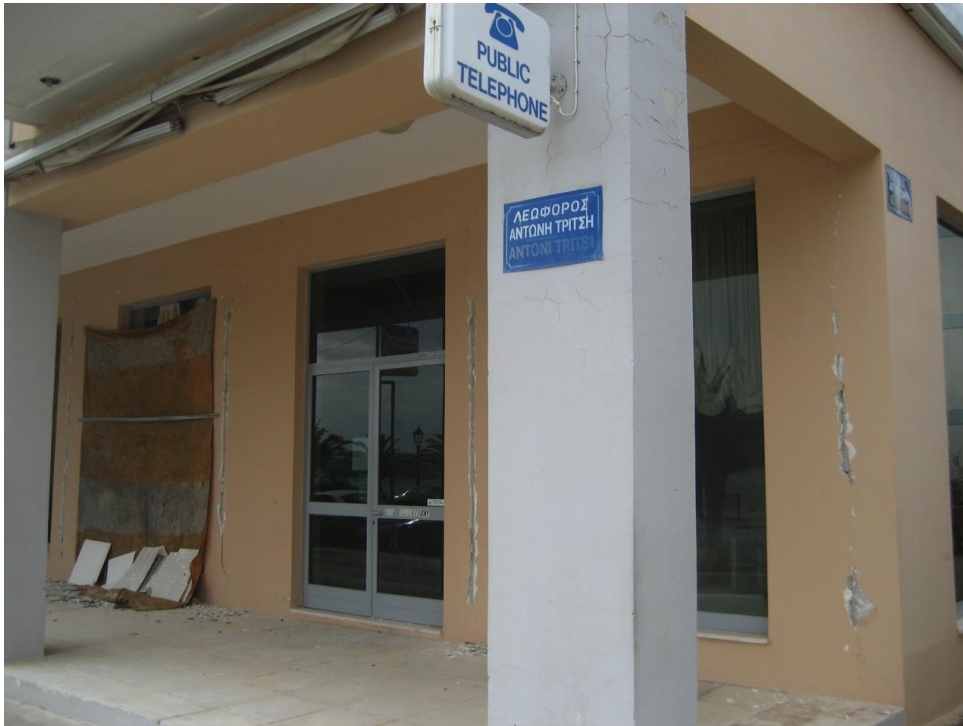
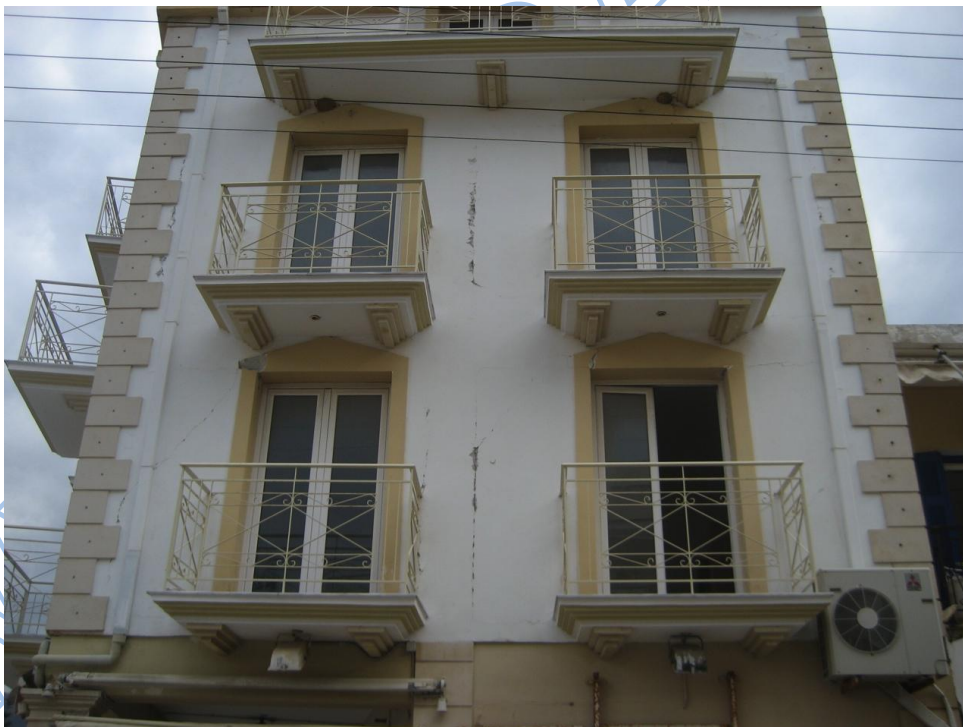
Photos 3.5, 3.6. Multistory buildings with detachment of infill walls from the R/C frames. No damage to the structural elements were observed.

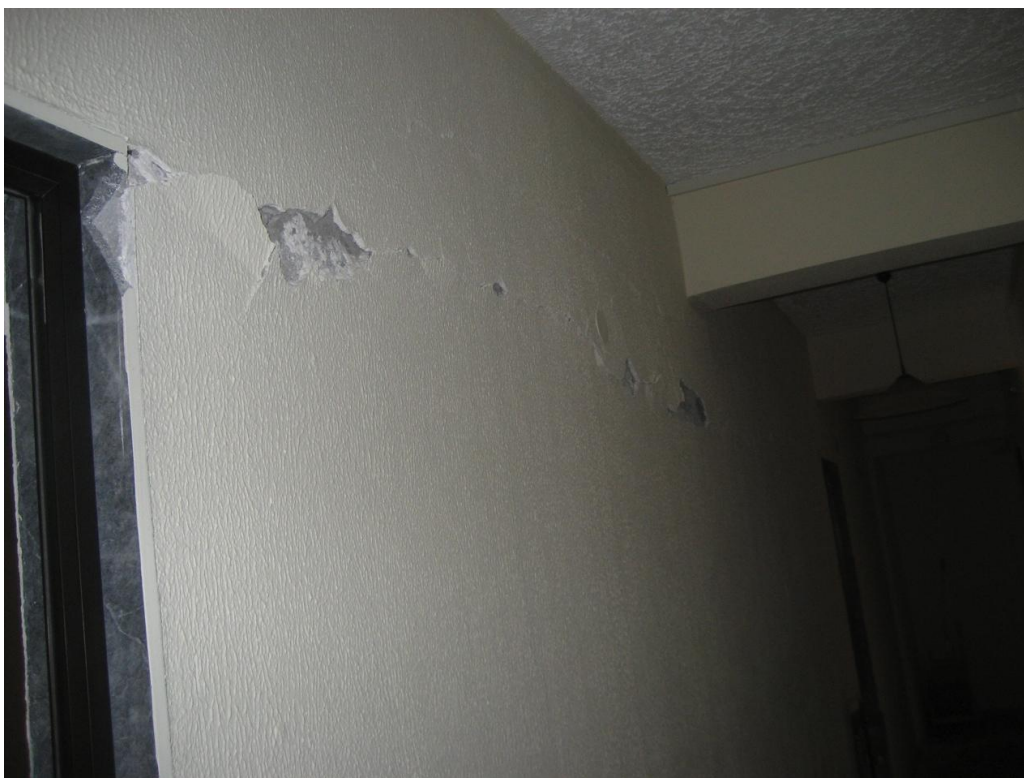
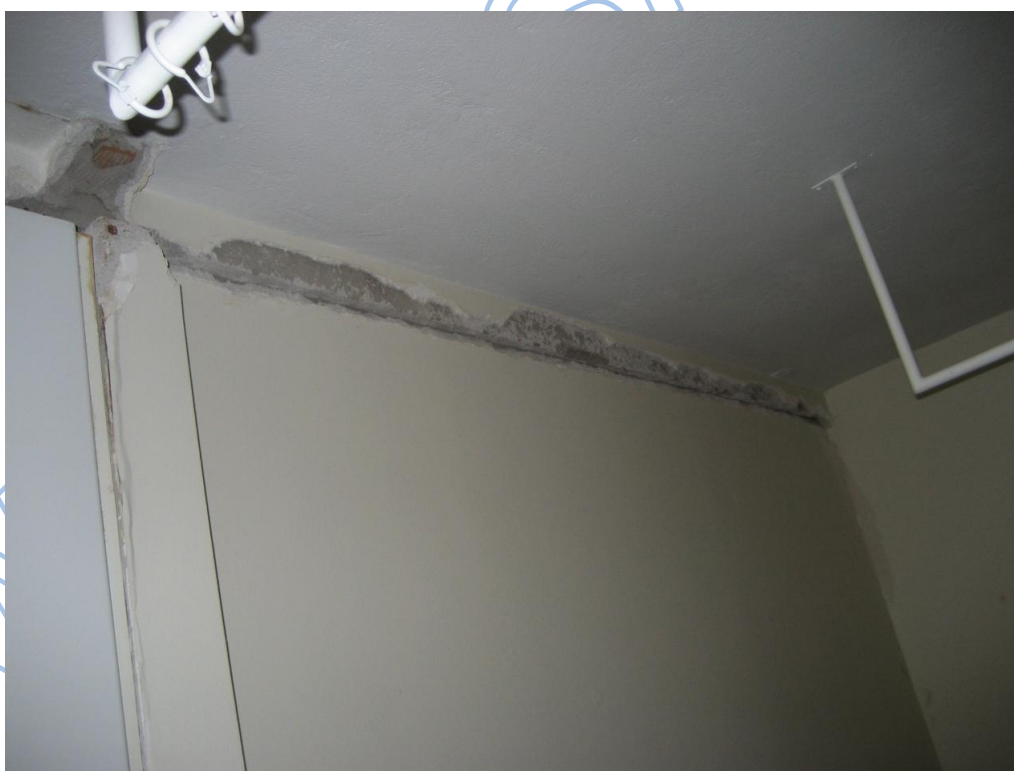
Photos 3.7, 3.8. Cracks between structural element and infill walls of the elderly people nursery (up) and the hospital (bottom) at Argostoli. These buildings were temporarily abandoned.

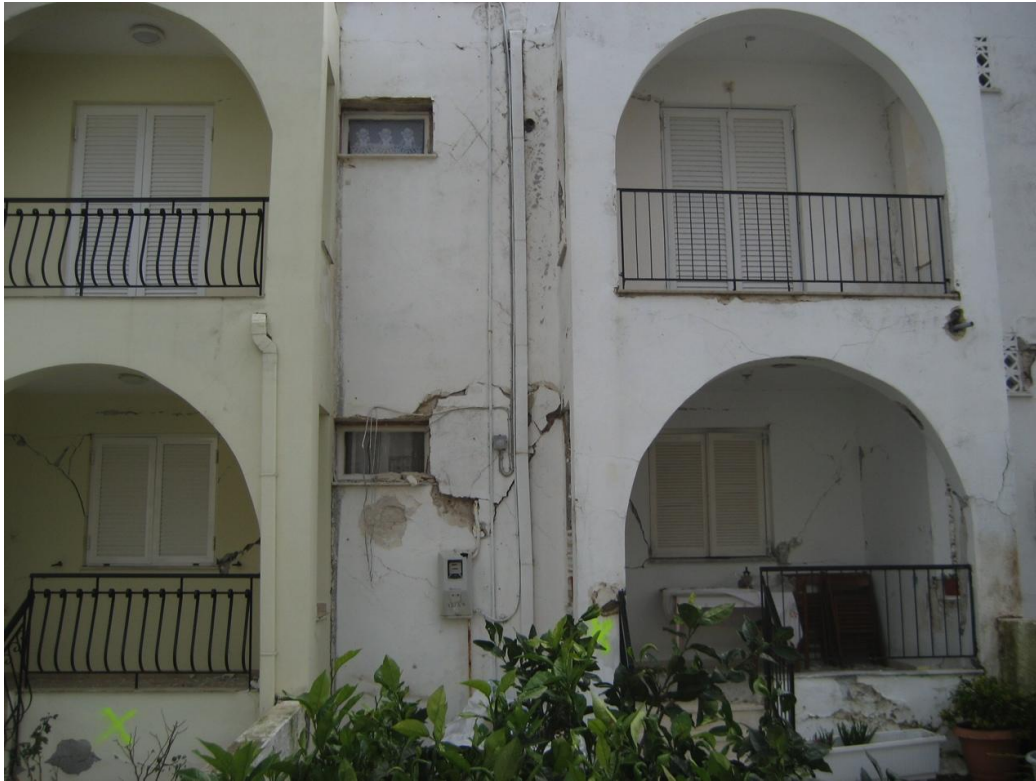
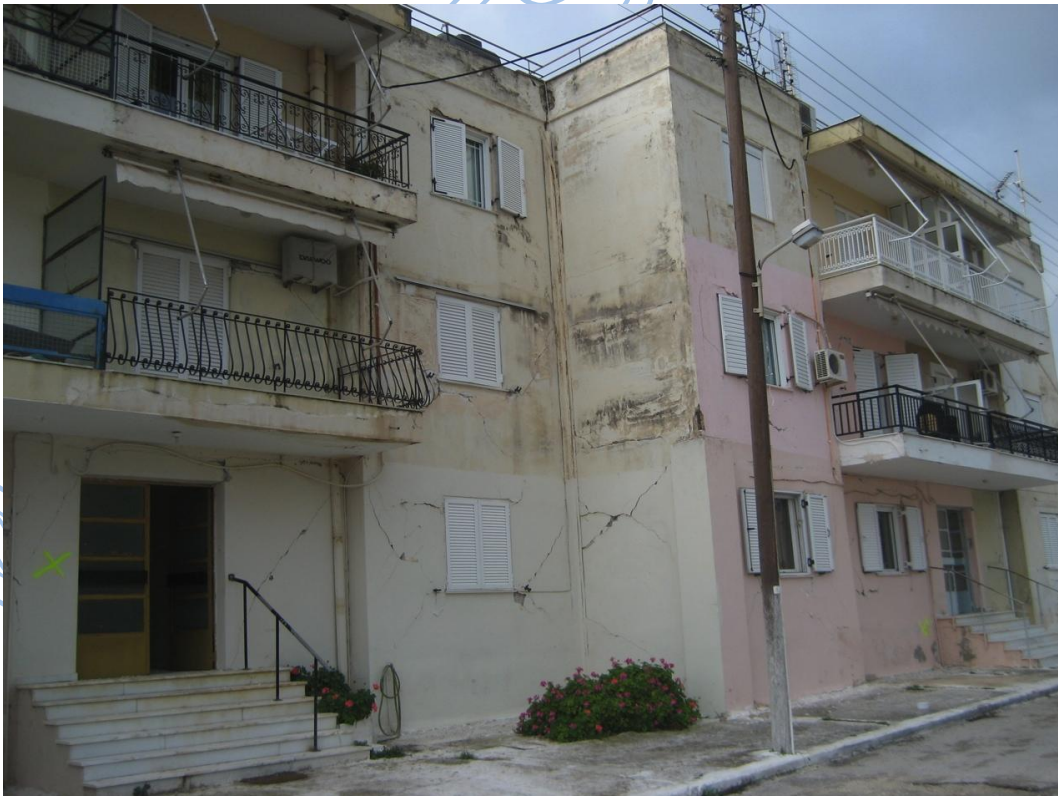
Photos 3.9, 3.10. Damage at the Labour houses at Lixouri.

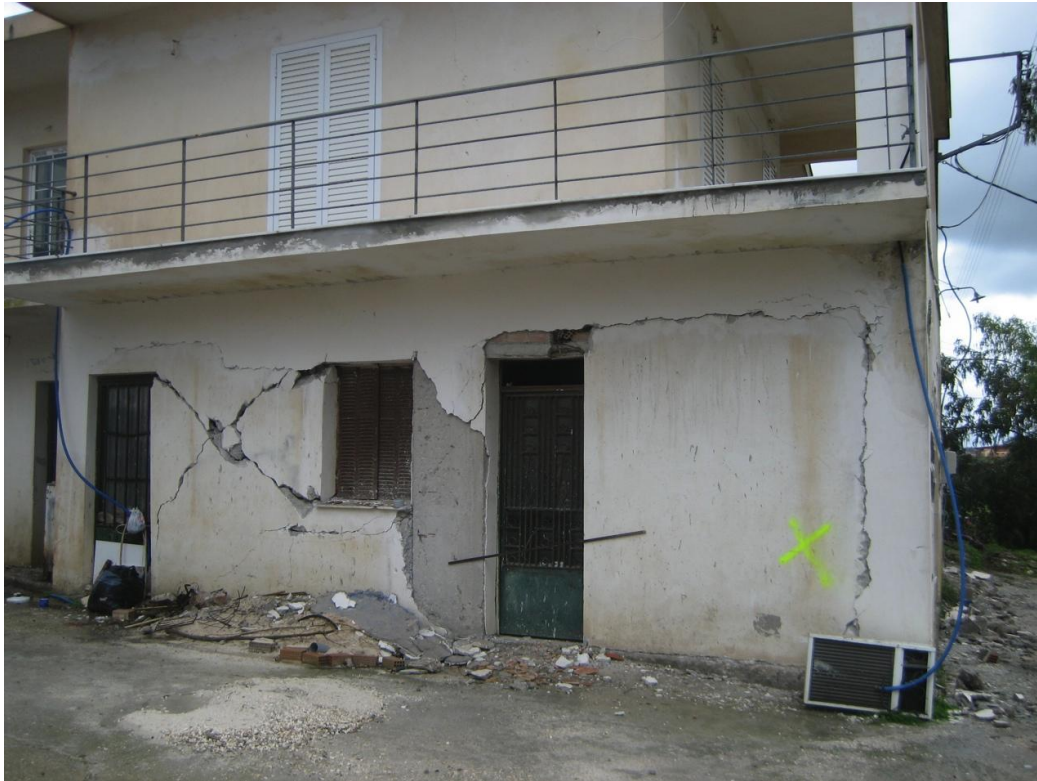
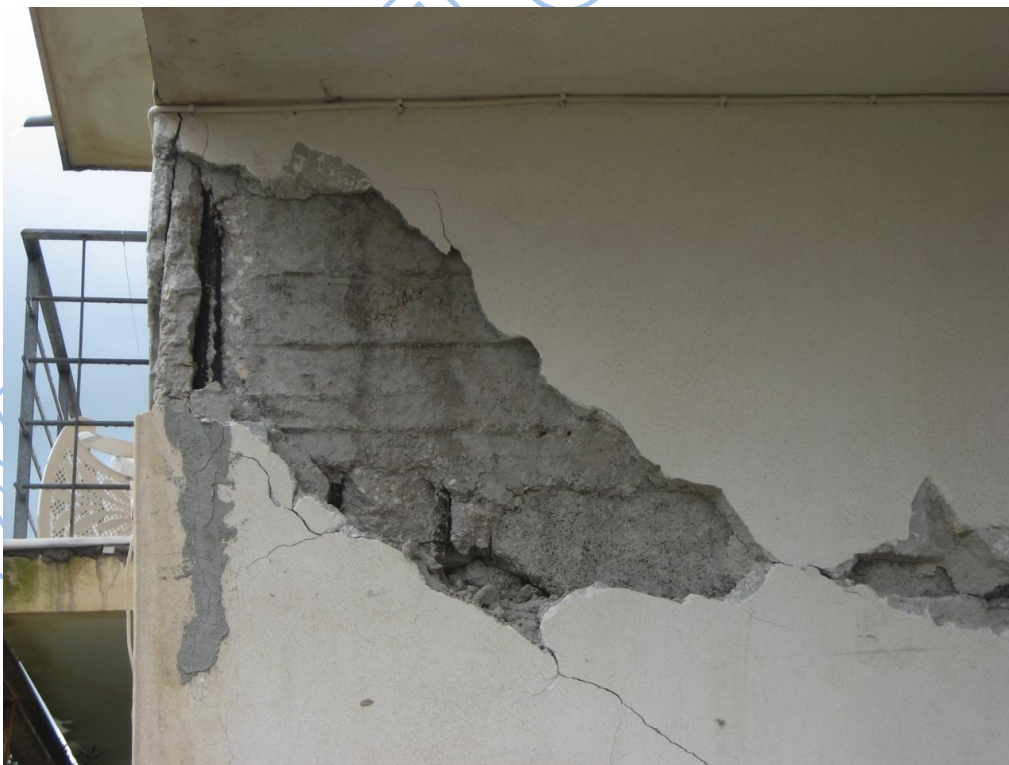
Photos 3.11, 3.12. Damage at a two storey building in Agios Dimitrios.

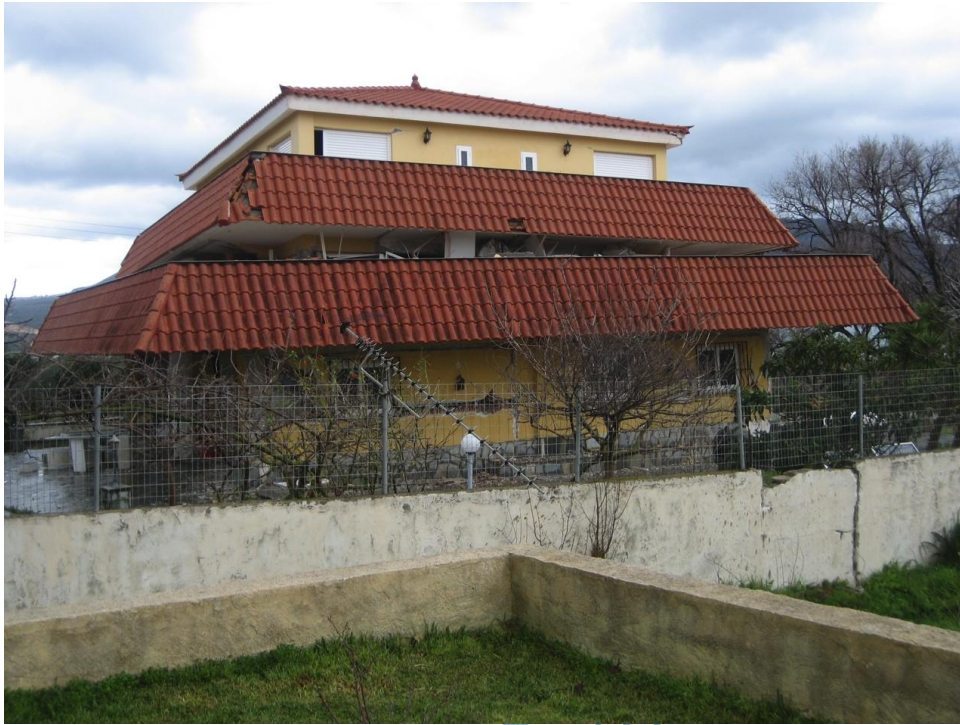
Photos 3.13, 3.14. Three storey building severely damaged in Livadi. Total collapse of

second floor coming to rest on the ground floor.

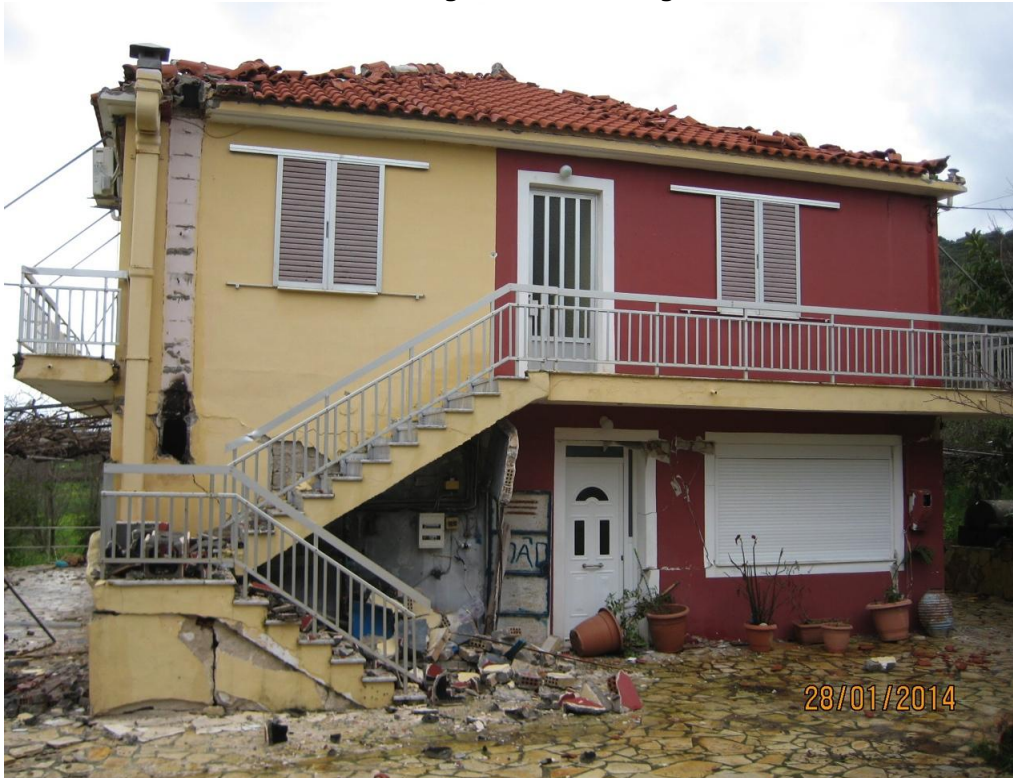
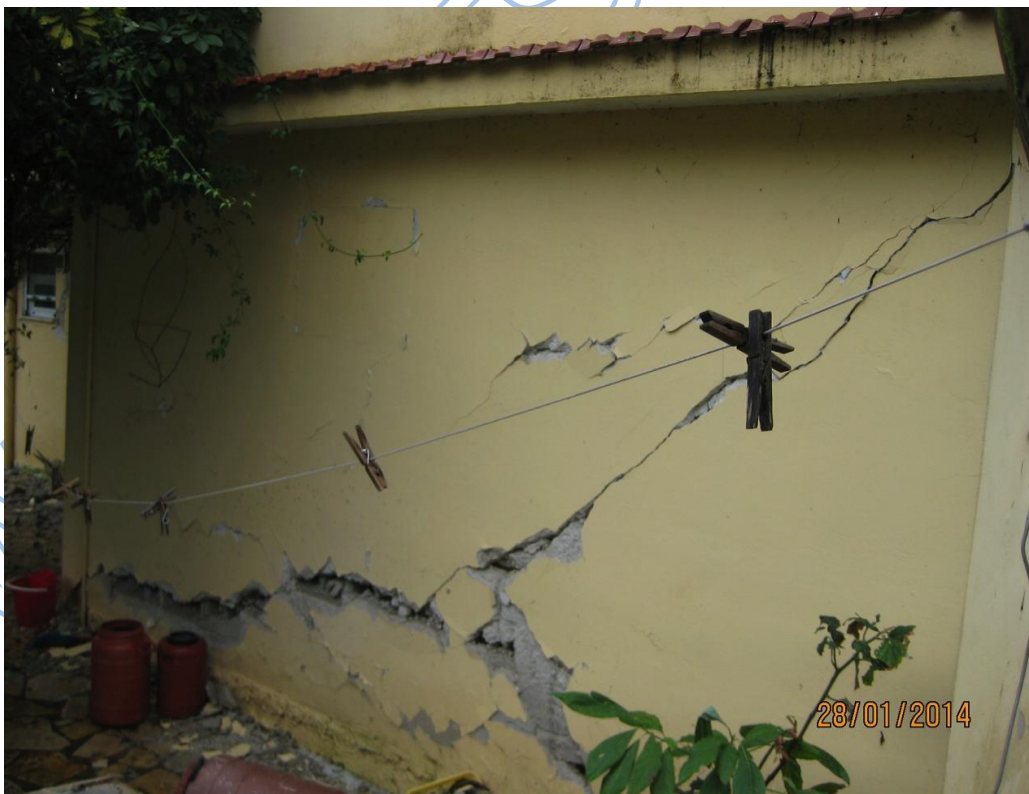
Photos 3.15, 3.16. Two storey building with damage, at the Northern road from Lixouri.

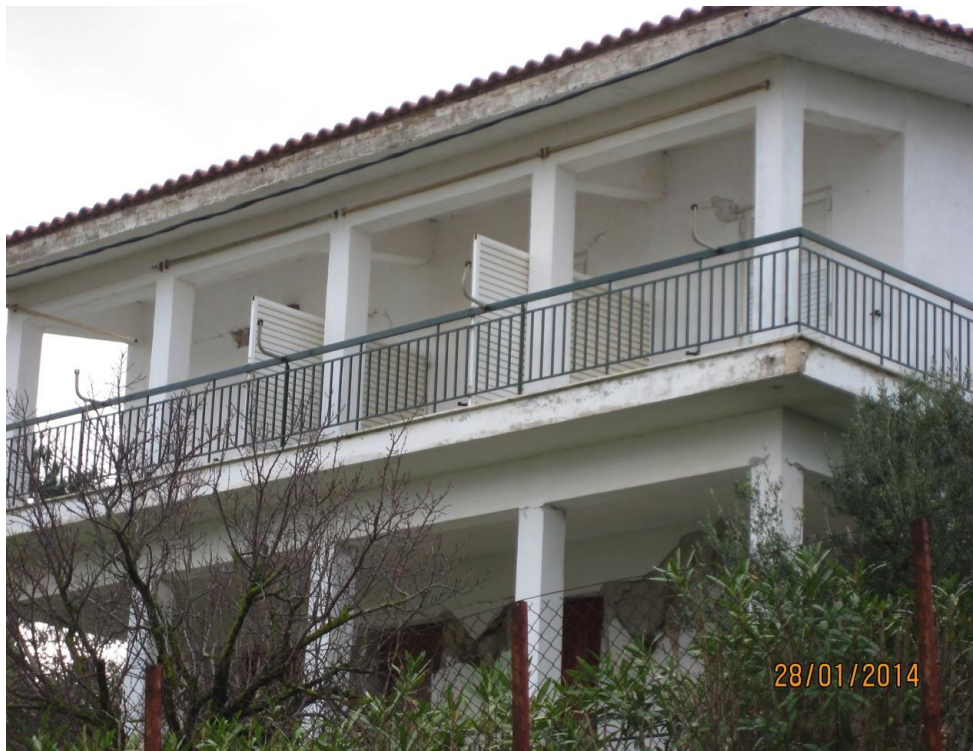
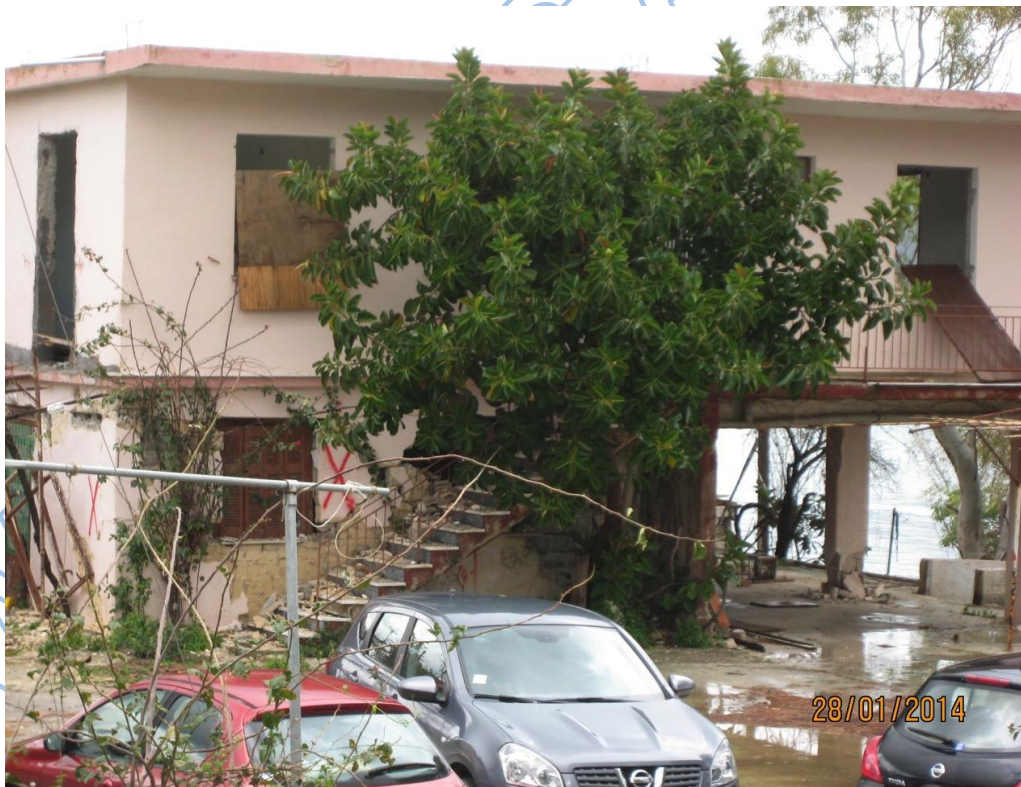
Photos 3.17, 3.18. Flexural cracks at the ends of R/C columns at the Northern road from Lixouri.
