KEFALONIA EARTHQUAKE 26/1/2014 AND 3/2/2014

Technical Report · May 2014

STRONG GROUND MOTION OF THE FEBRUARY 3, 2014 (M6.0) CEPHALONIA EARTHQUAKE: EFFECTS ON SOIL AND BUILT ENVIRONMENT IN COMBINATION WITH THE JANUARY 26, 2014 (M6.1) EVENT

**T H E S S A L O N I K I
F E B R U A R Y 2 0 1 4**

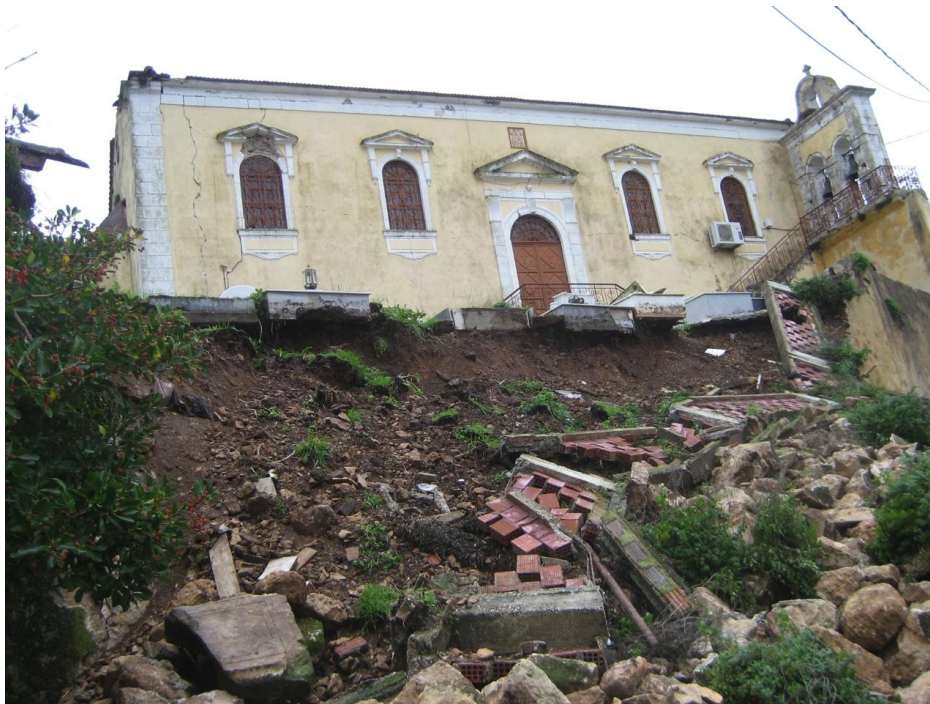
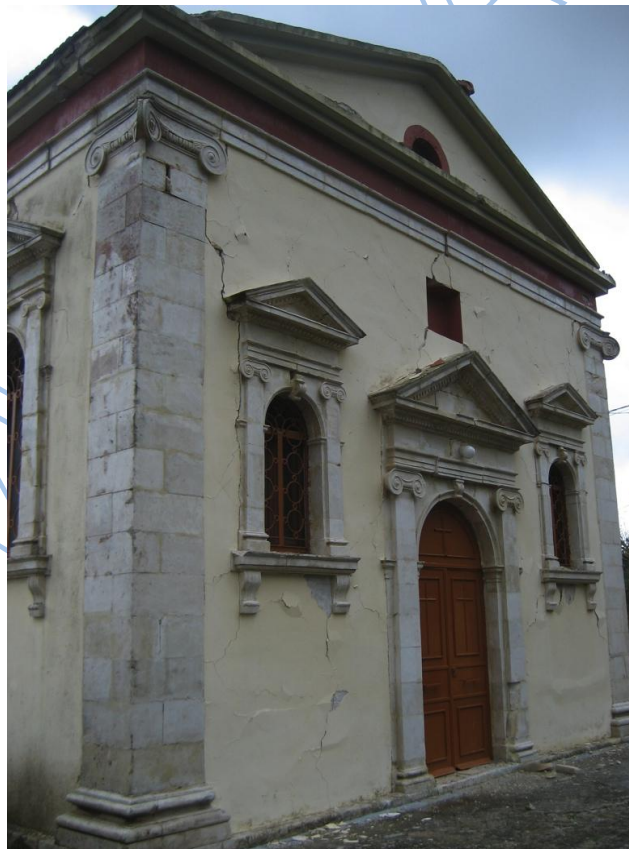
Photos 3.23, 3.24. Cultural heritage masonry building and temple, with damage, at the center of Paliki peninsula.

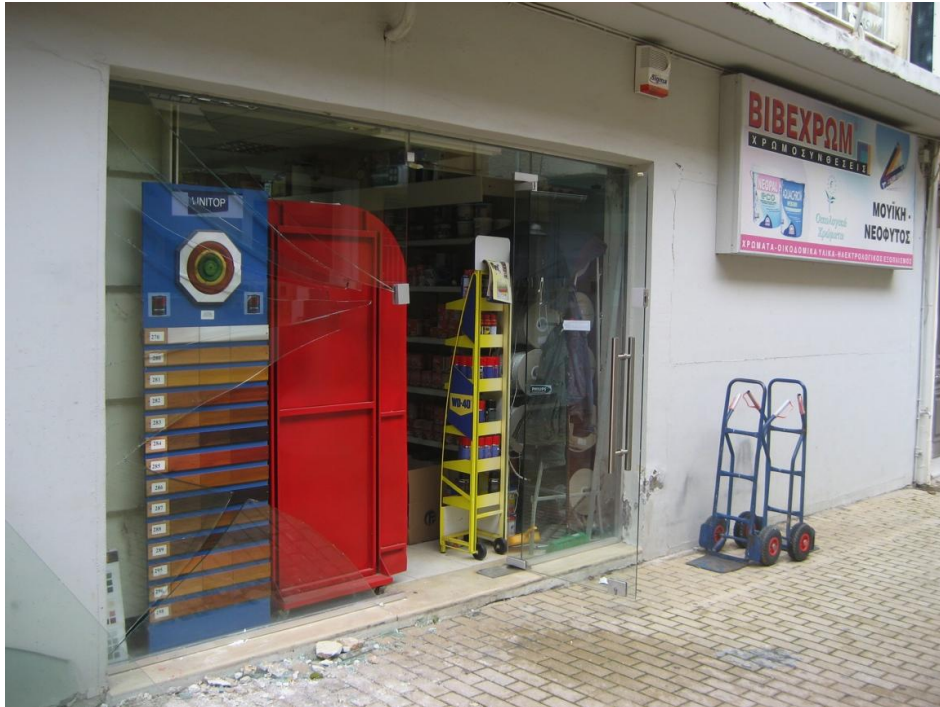
Photo 3.25. Damage at glass panes.

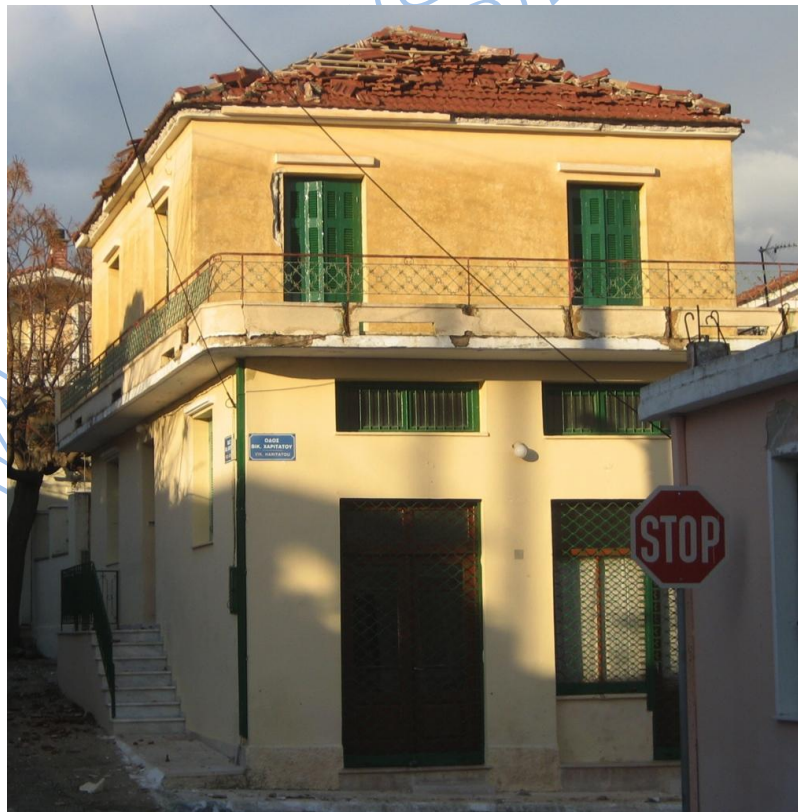
Photo 3.26. Damage on tile - roofs.

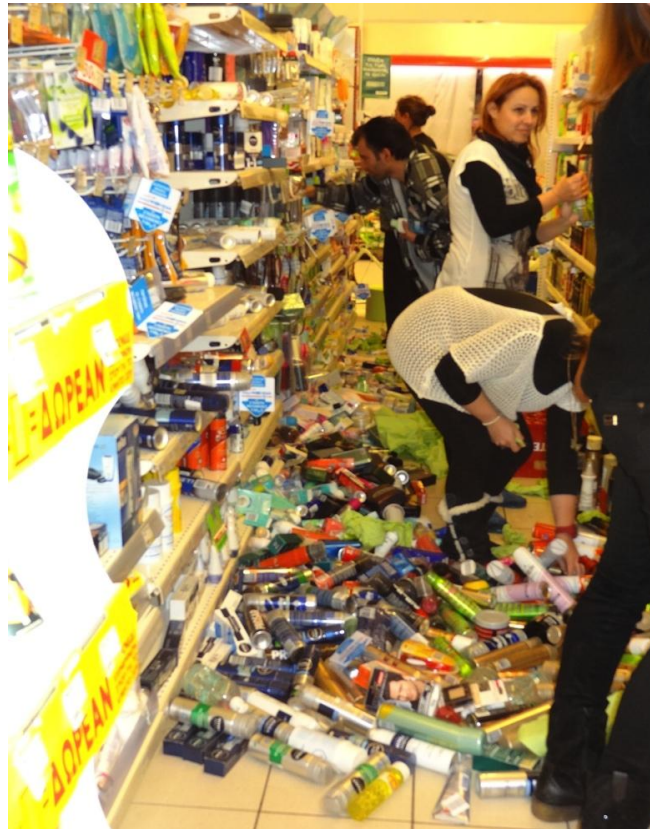
Photo 3.27. Damage of commercial wares.

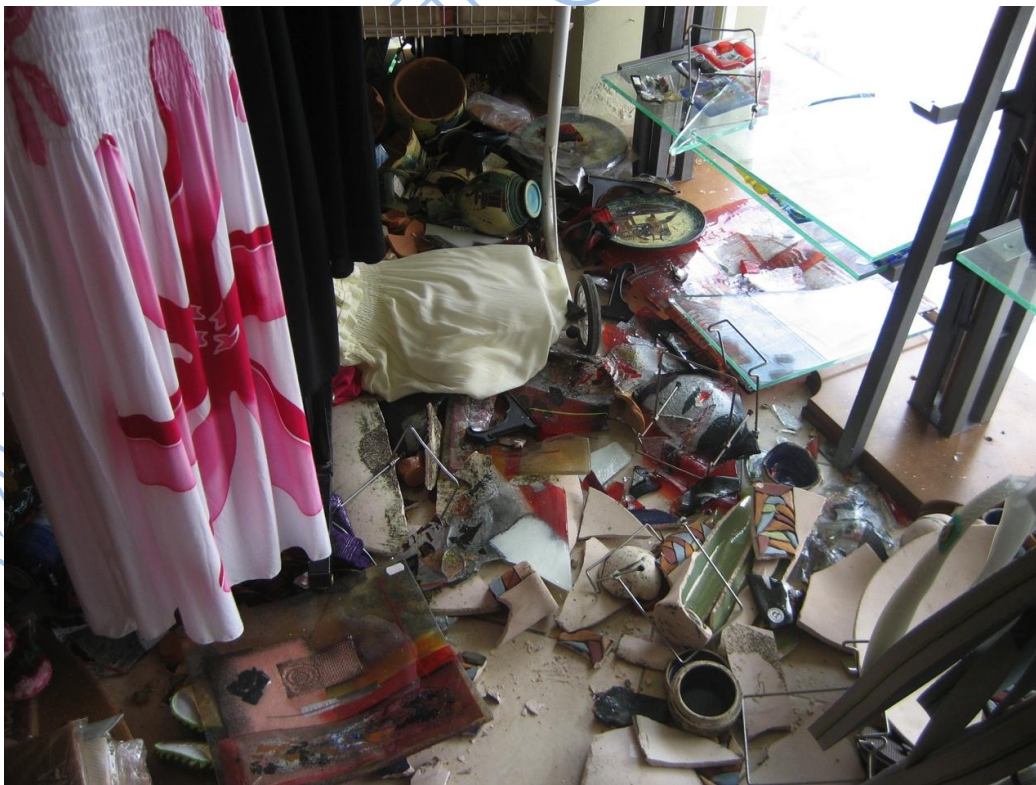
Photo 3.28. Damage of commercial wares

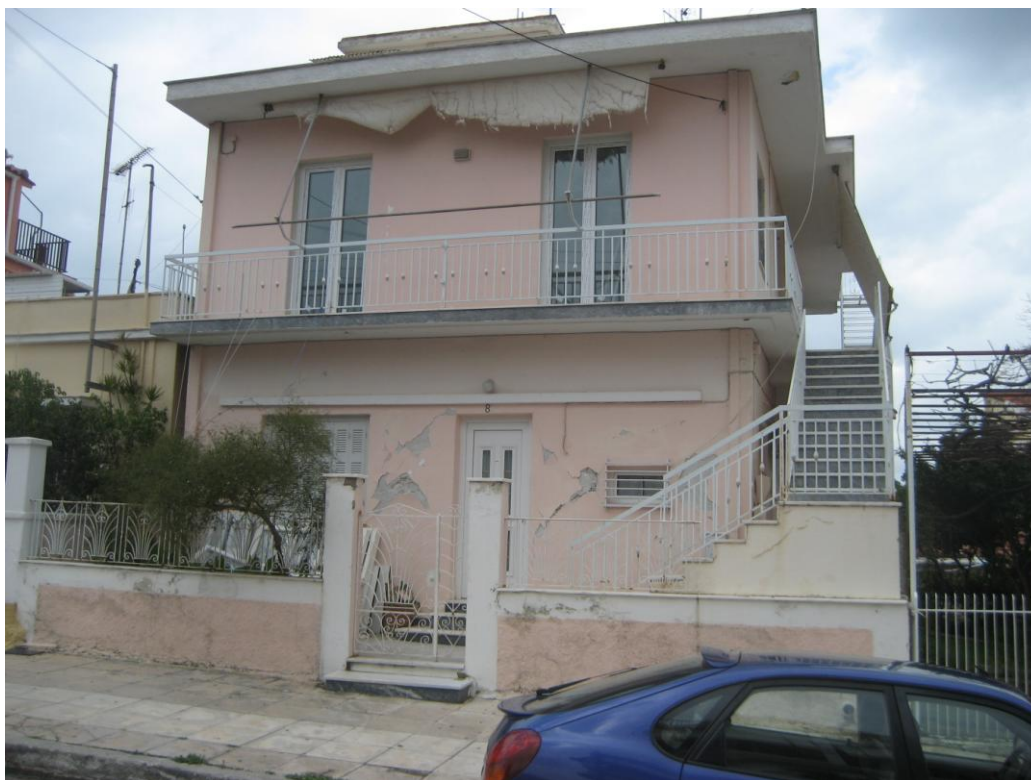
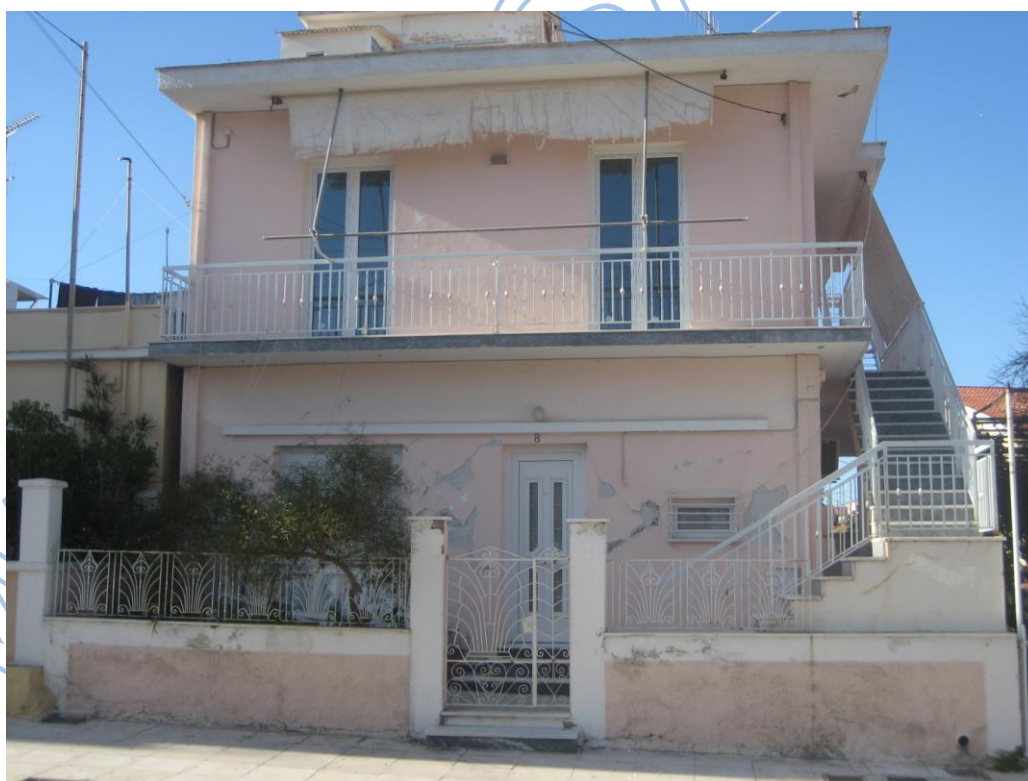
Photos 3.29, 3.30. Building in Argostoli as damaged during 26-1-2014 (up) and during 3-2-2014 (low) earthquakes.

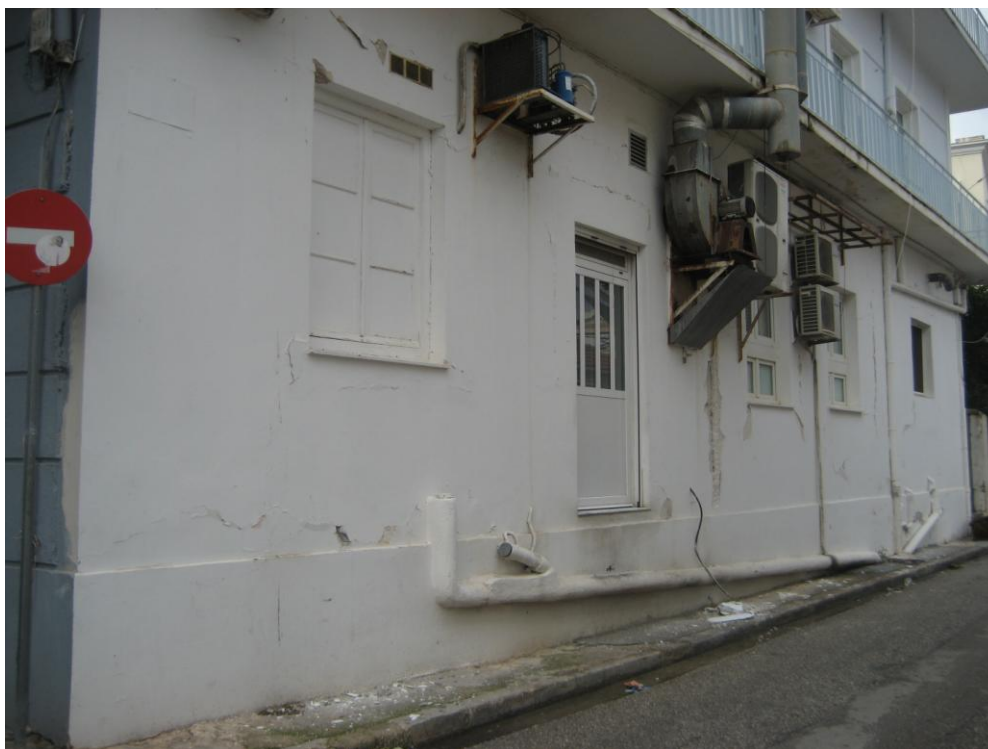
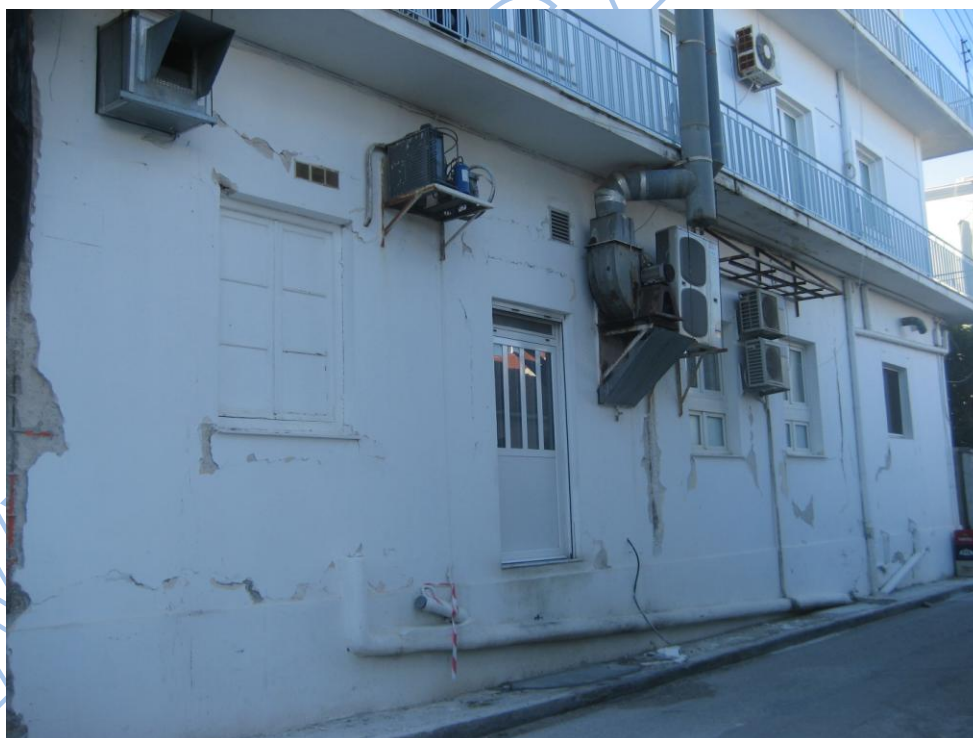
Photos 3.31, 3.32. Building in Argostoli as damaged during 26-1-2014 (up) and during 3-2-2014 (low) earthquakes.

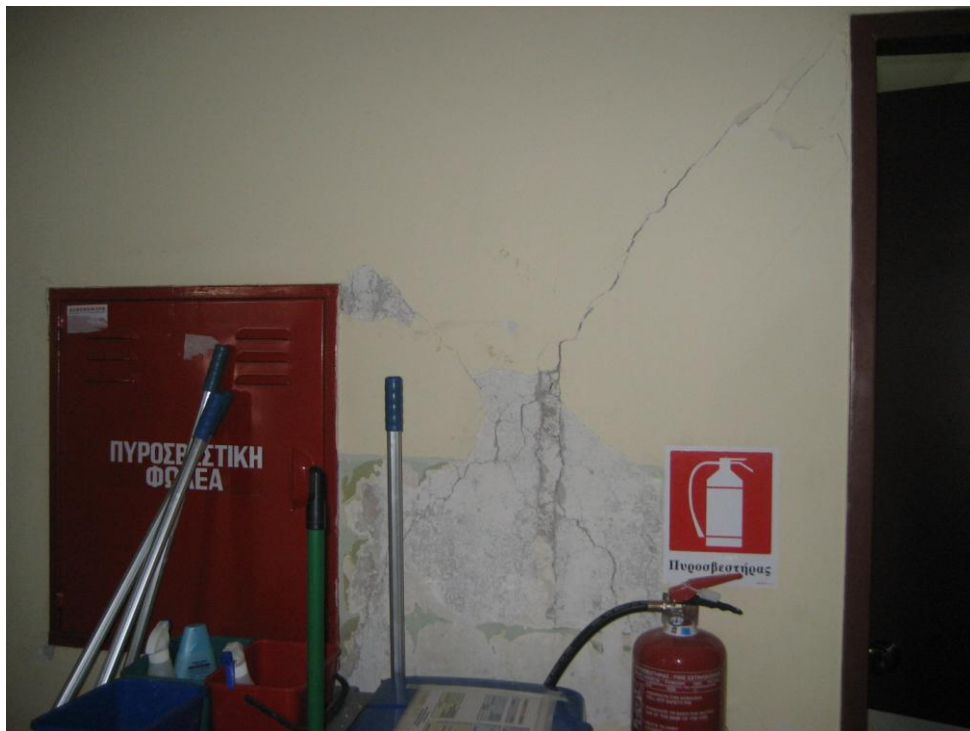
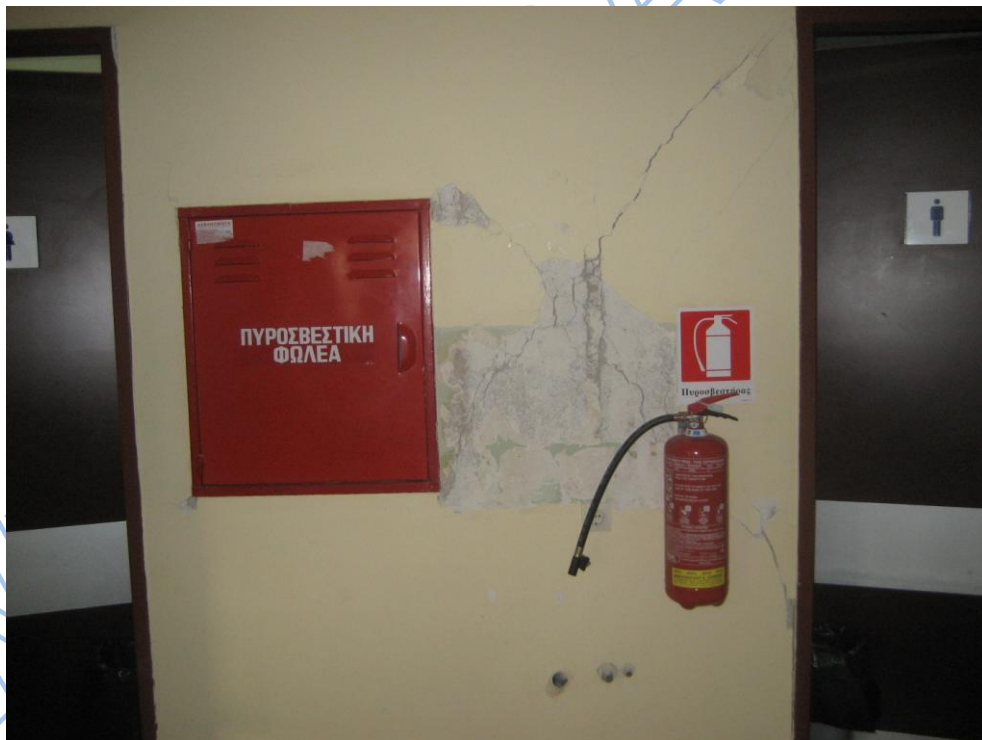
Photos 3.33, 3.34. Hospital in Argostoli as damaged during 26-1-2014 (up) and during 3-2-2014 (low) earthquakes.

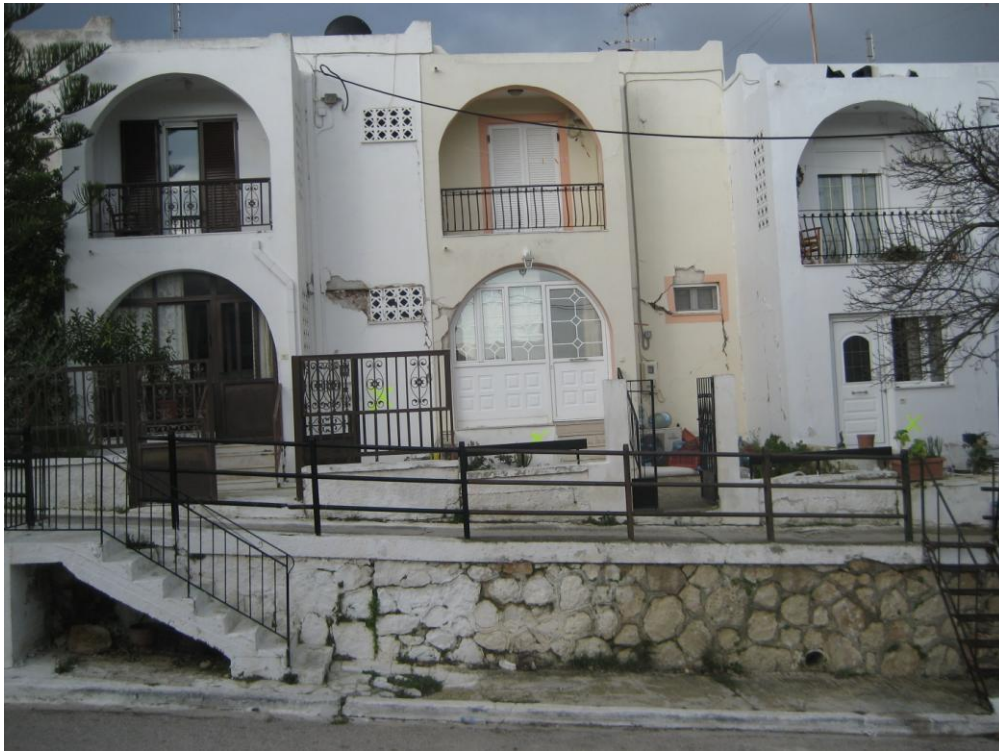
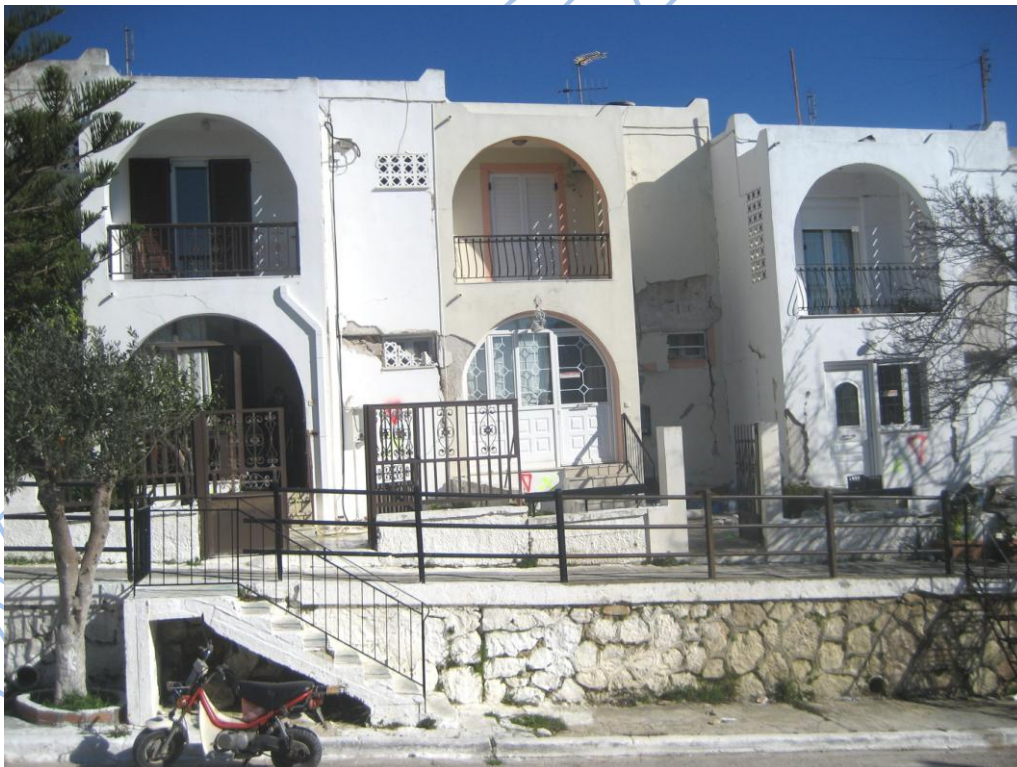
Photos 3.35, 3.36. Labor houses in Lixouri as damaged during 26-1-2014 (up) and during 3-2-2014 (low) earthquakes.

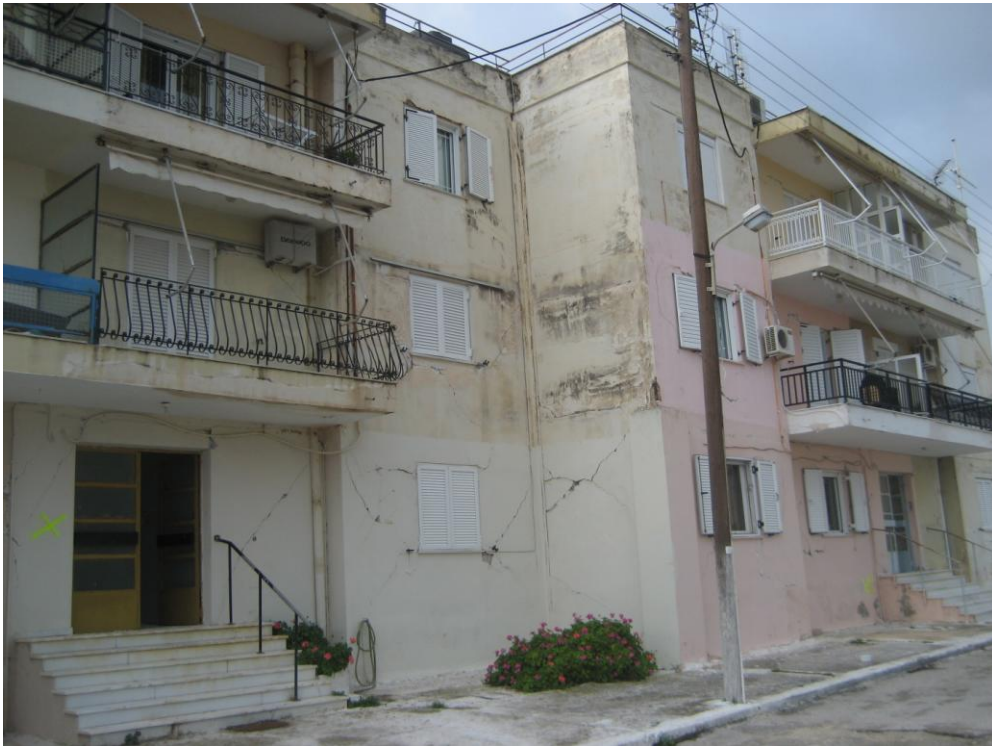
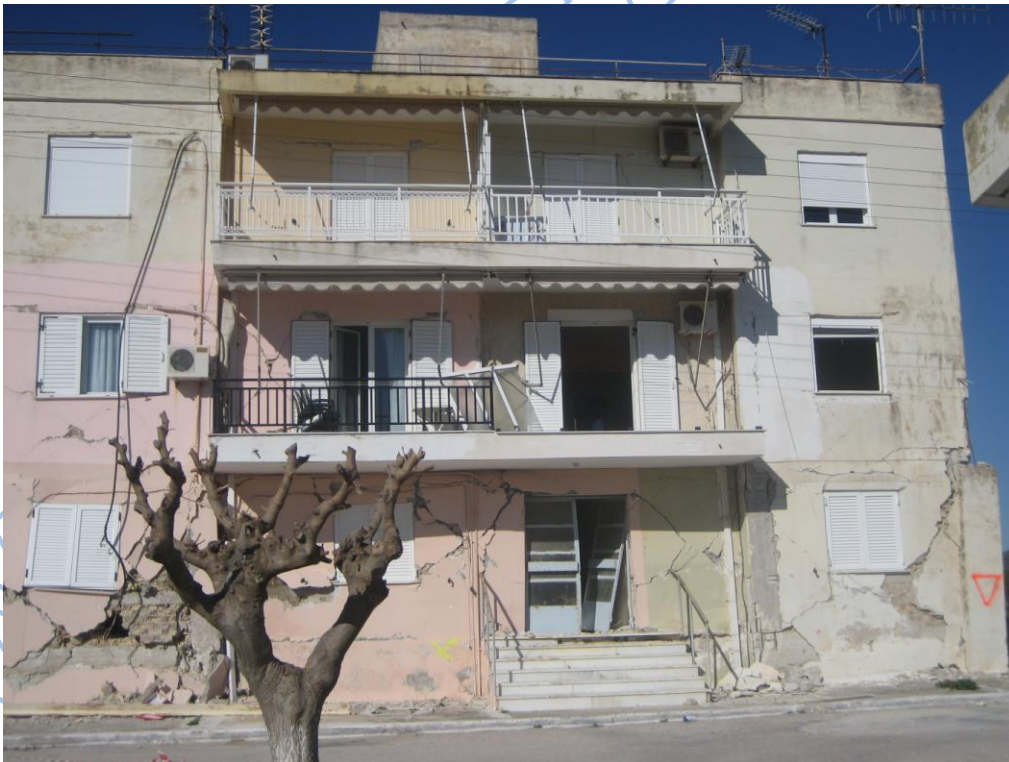
Photos 3.37, 3.38. Labor houses in Lixouri as damaged during 26-1-2014 (up) and during 3-2-2014 (low) earthquakes.

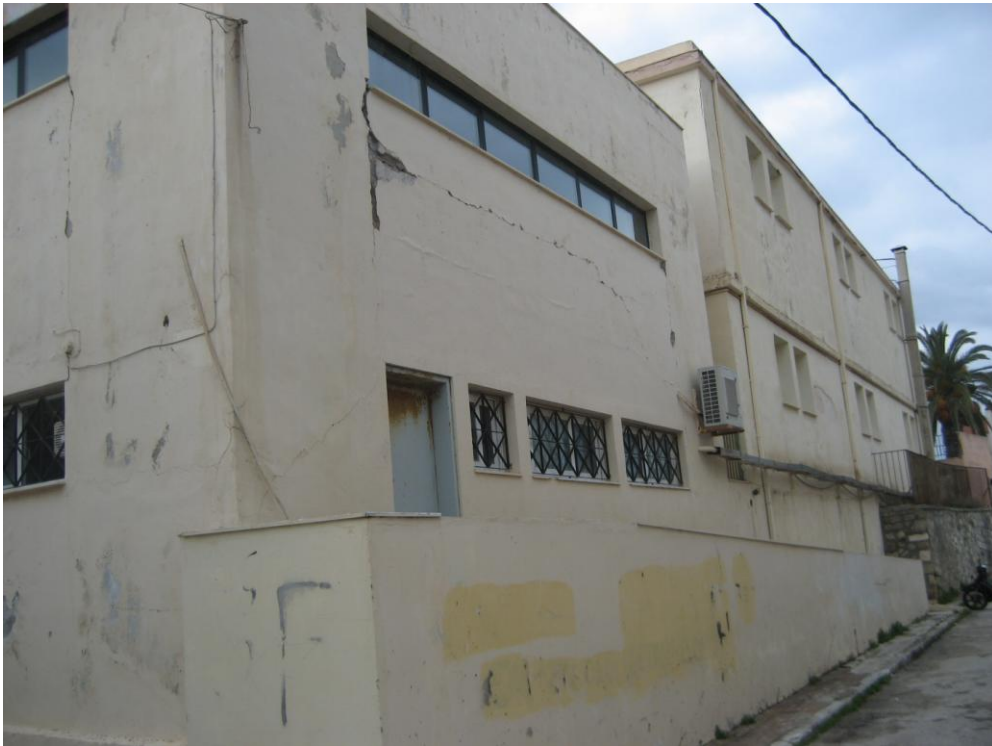
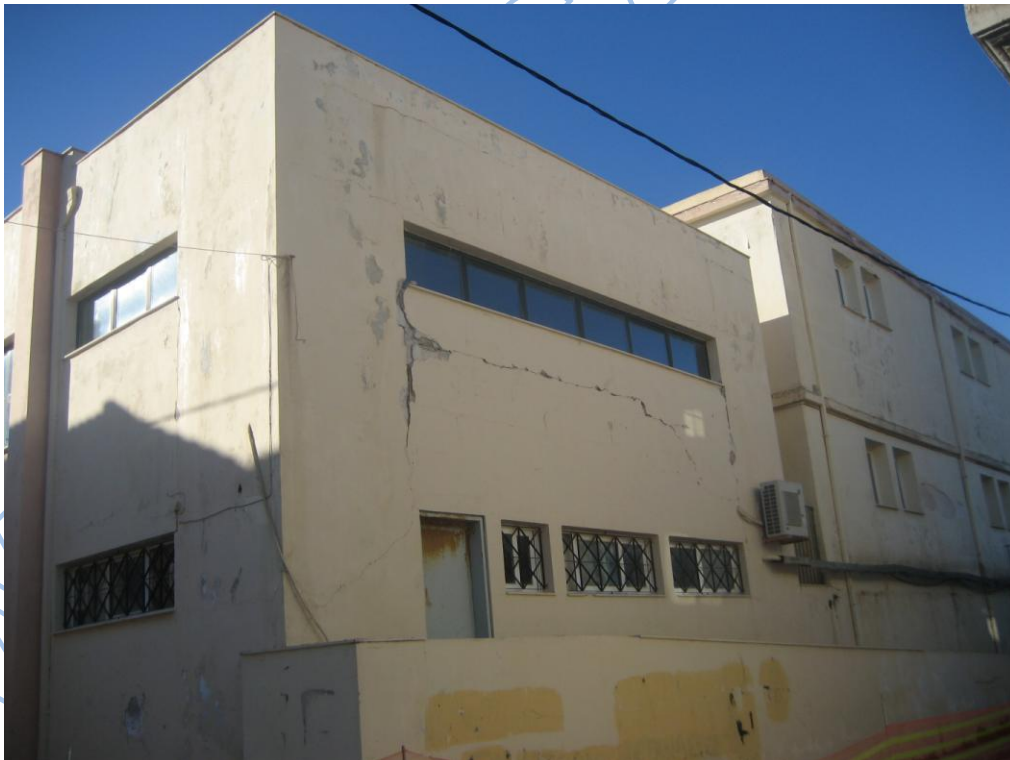
Photos 3.39, 3.40. School building in Lixouri as damaged during 26-1-2014 (up) and during 3-2-2014 (low) earthquakes.

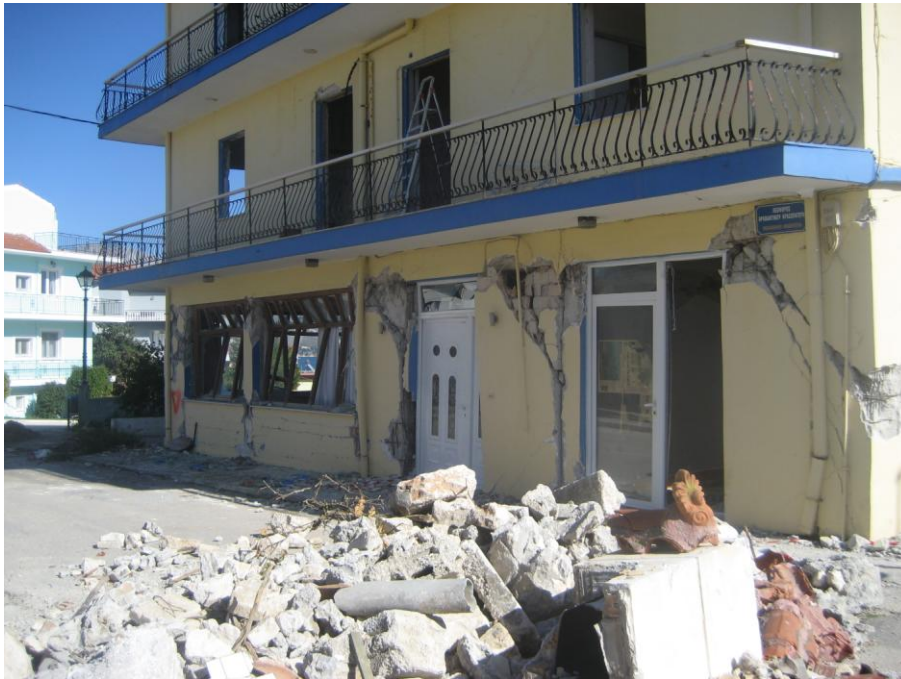
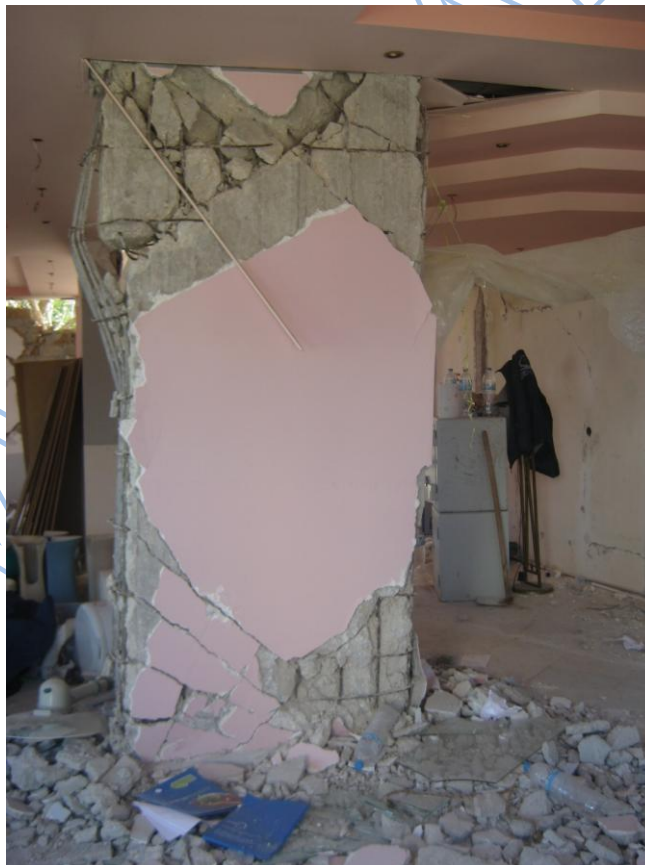
Photos 3.41, 3.42. Building in Lixouri as damaged during 3-2-2014 earthquake.

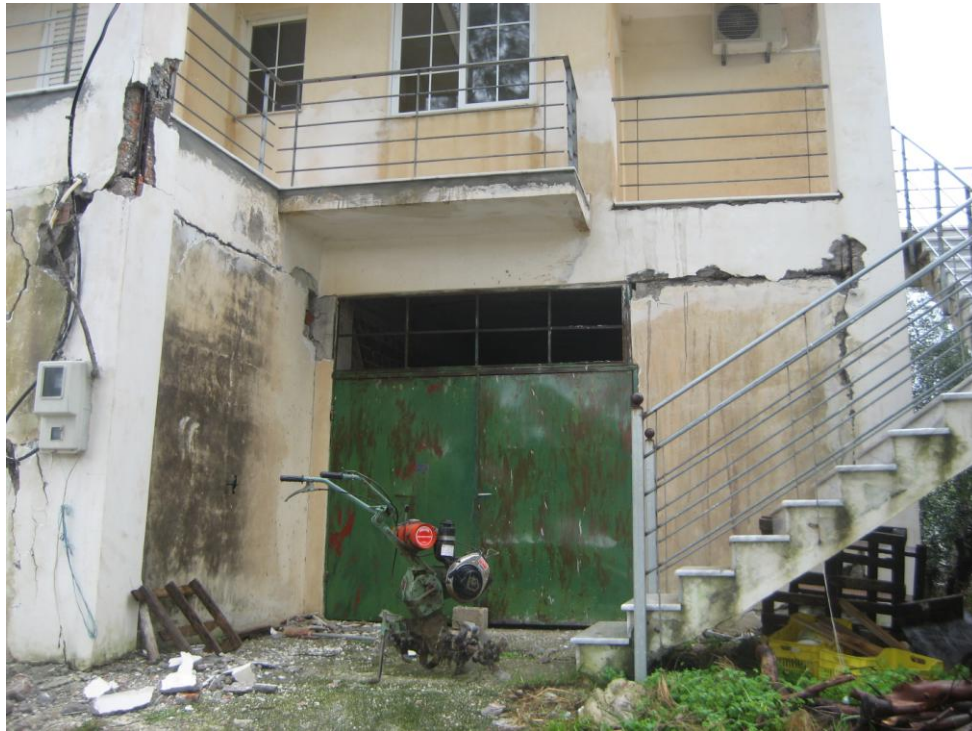
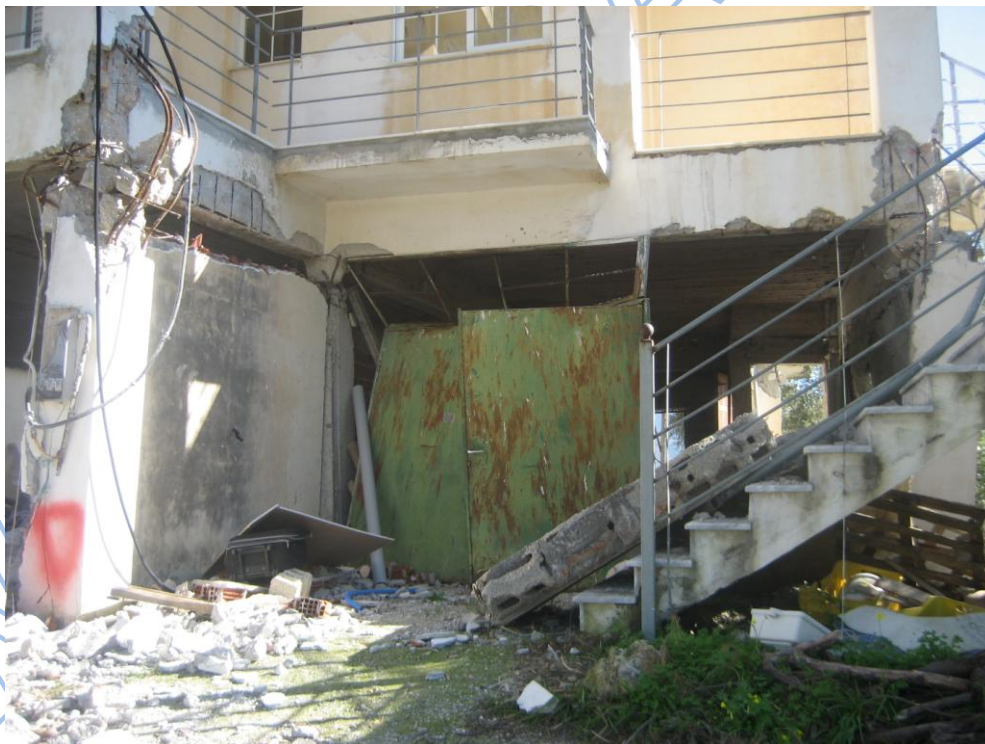
Photos 3.43, 3.44. Building in Agios Dimitrios as damaged during 26-1-2014 (up) and during 3-2-2014 (low) earthquakes.

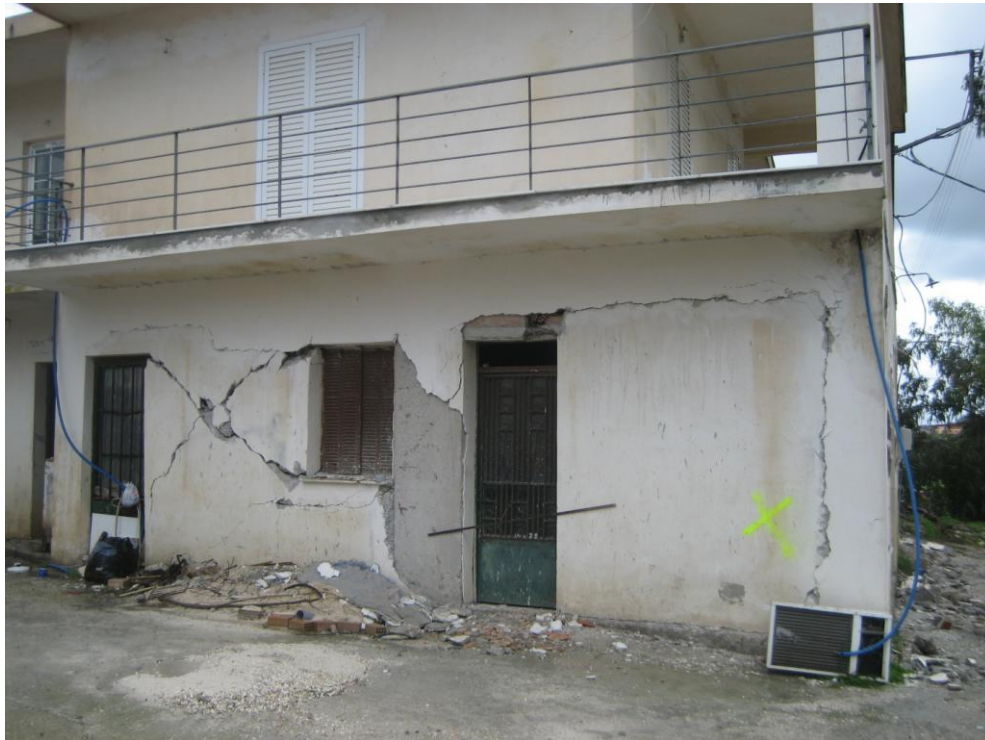
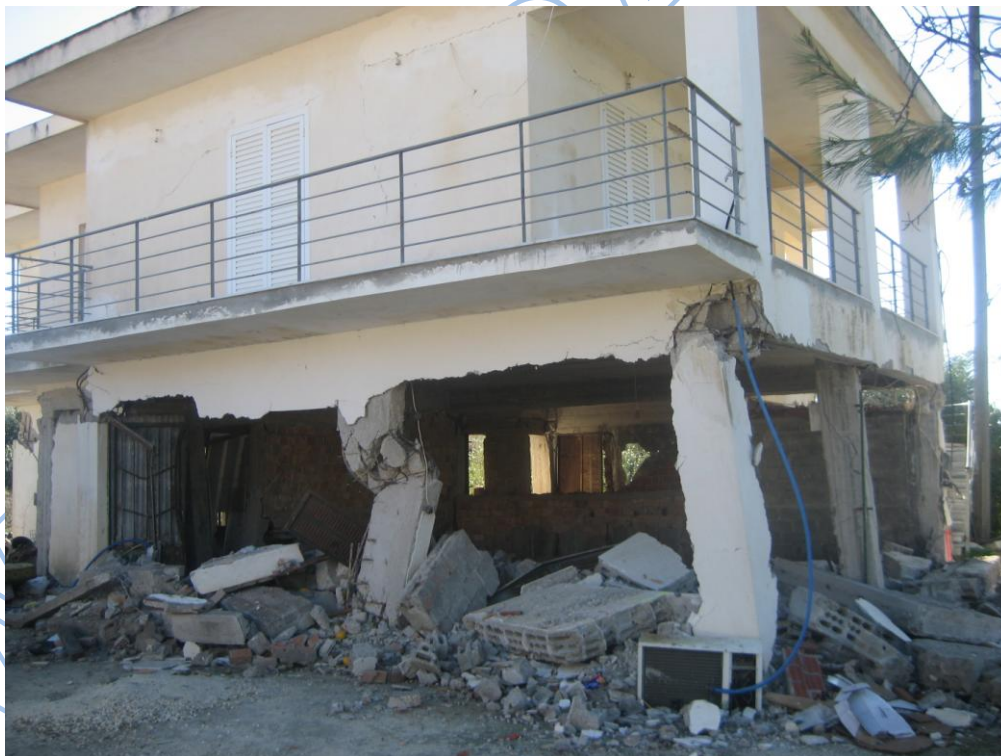
Photos 3.45, 3.46. Building in Agios Dimitrios as damaged during 26-1-2014 (up) and during 3-2-2014 (low) earthquakes.

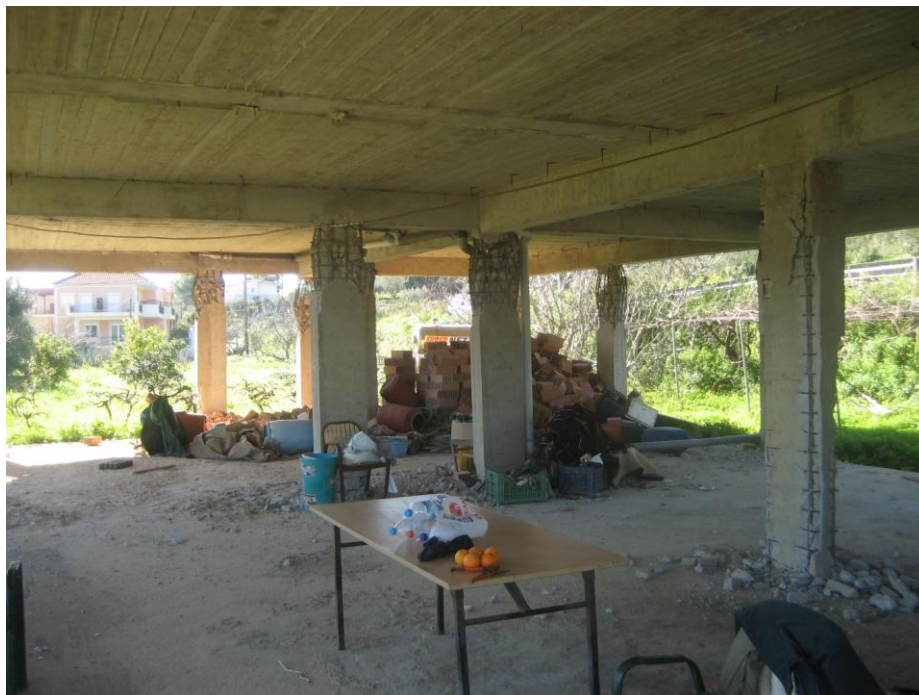
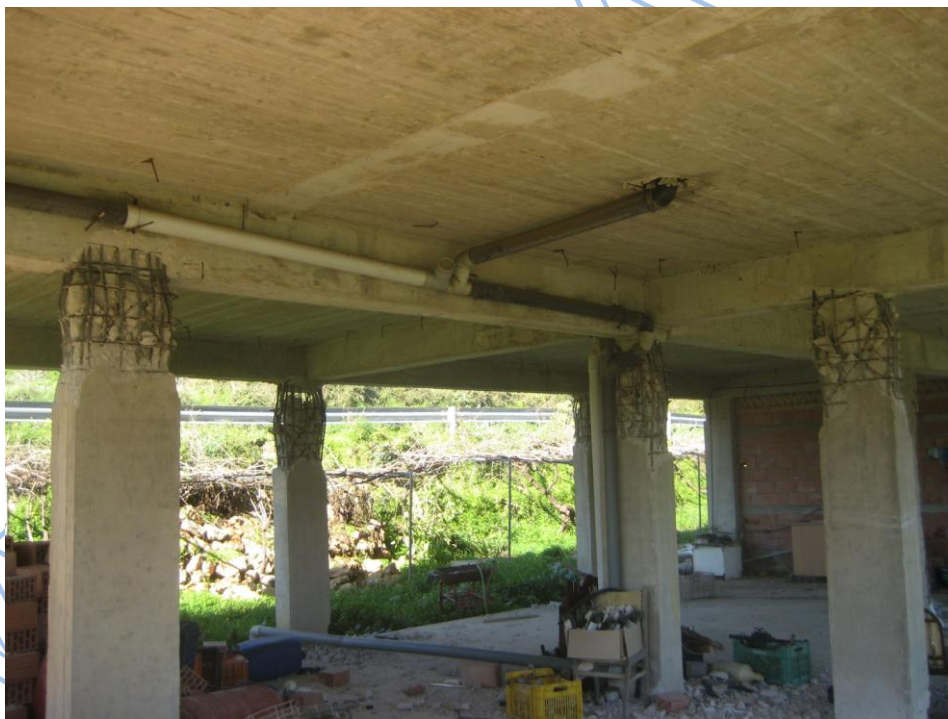
Photos 3.47, 3.48. Building on the way to Livadi as damaged during 3-2-2014 earthquake.

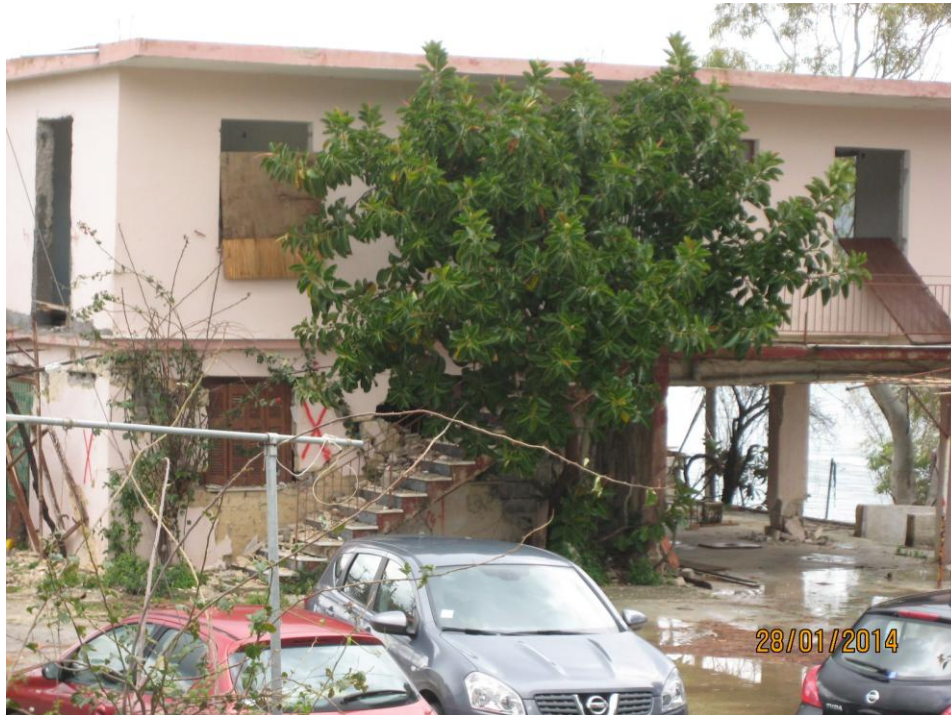
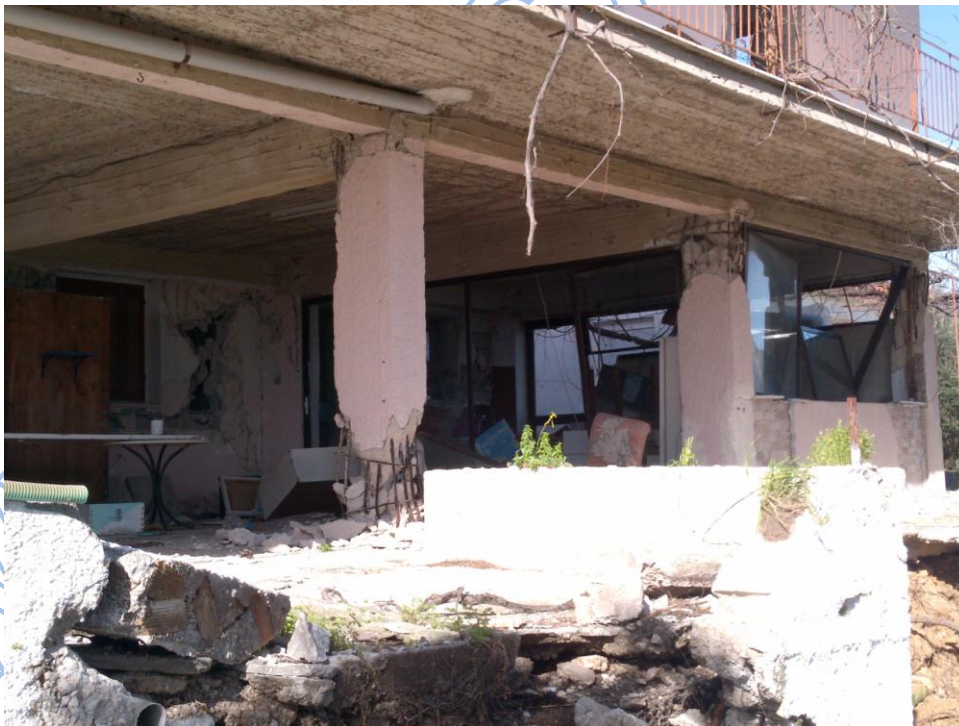
Photos 3.49, 3.50. Building on the way to Livadi as damaged during 26-1-2014 (up) and during 3-2-2014 (low) earthquakes.

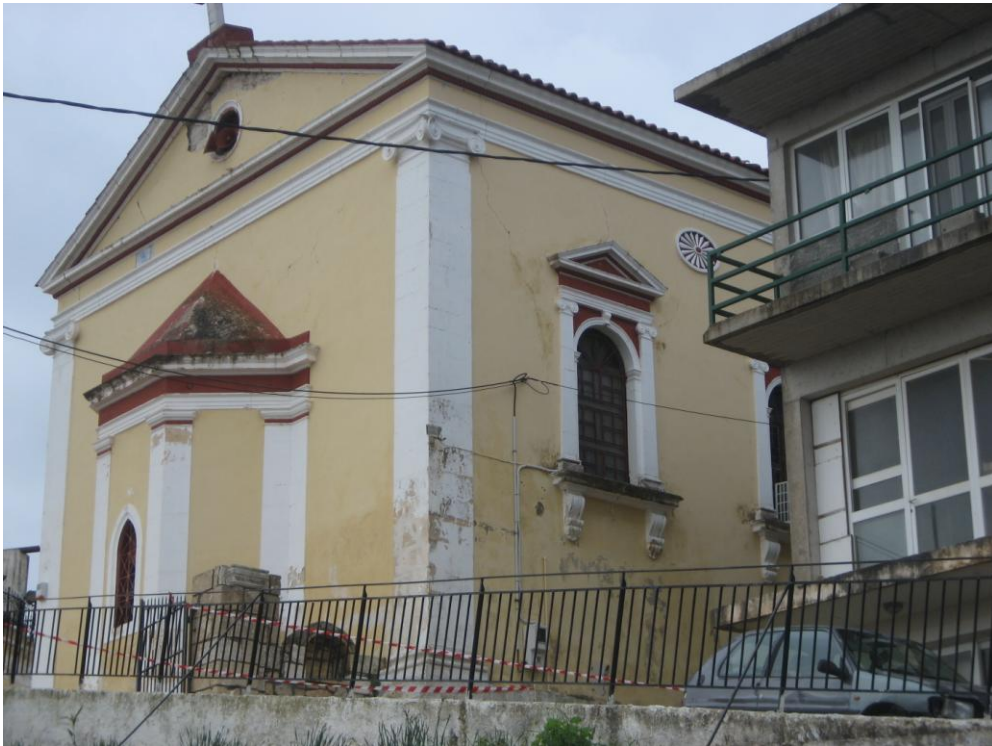
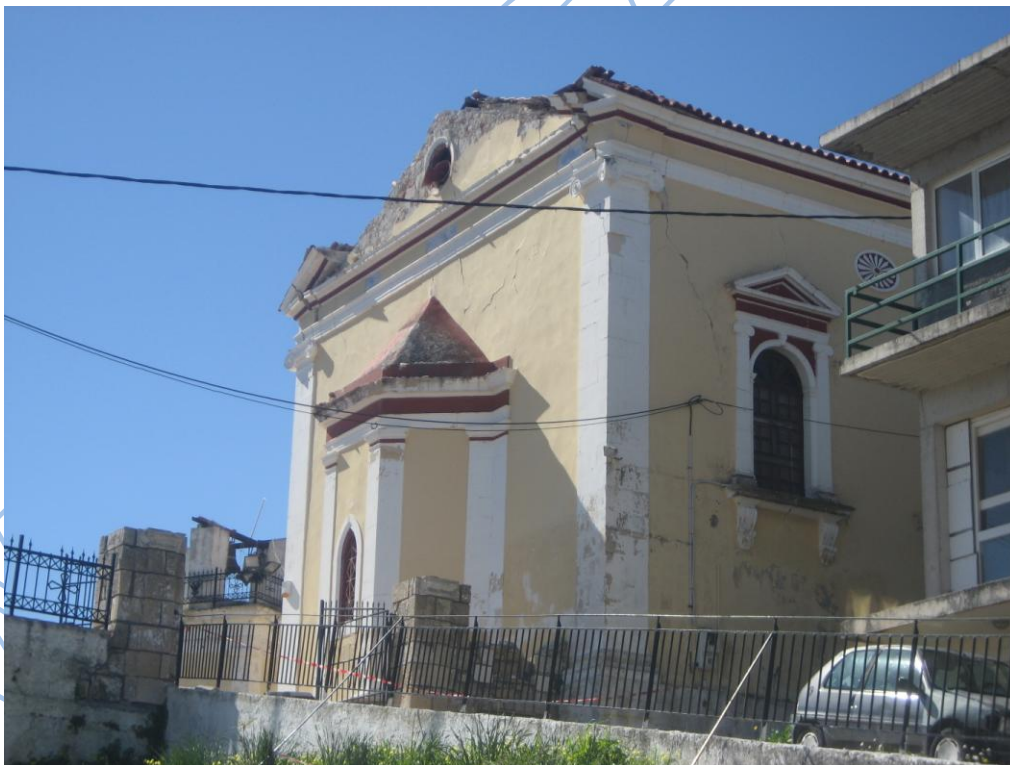
Photos 3.53, 3.54. Temple at a village of central Paliki peninsula as damaged during 26-1-2014 (up) and during 3-2-2014 (low) earthquakes.

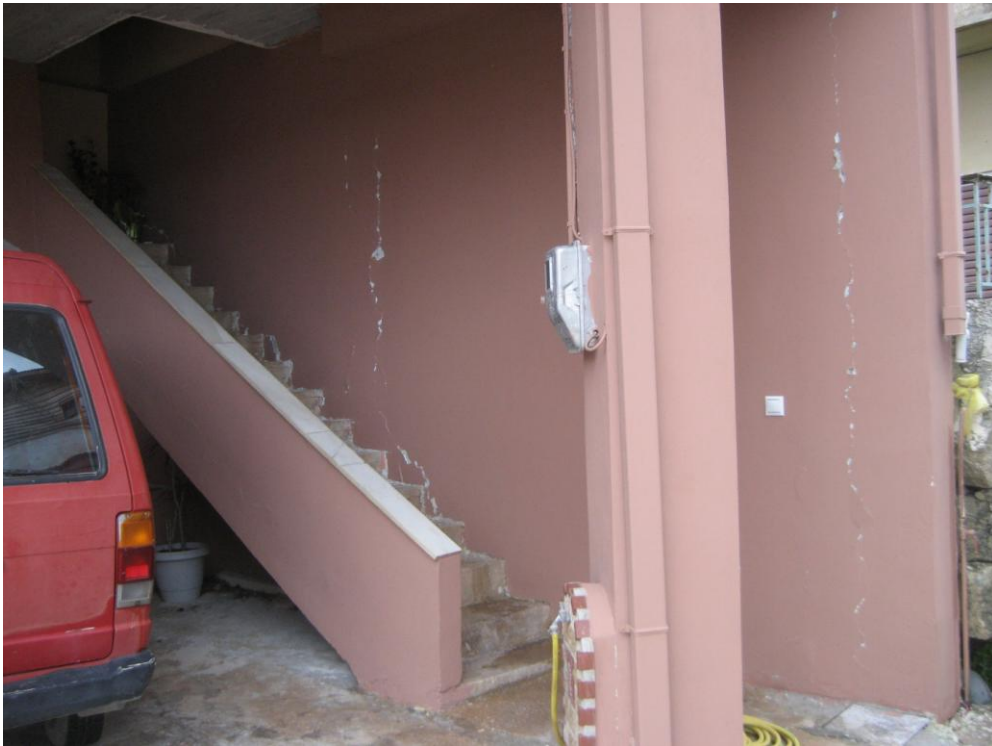
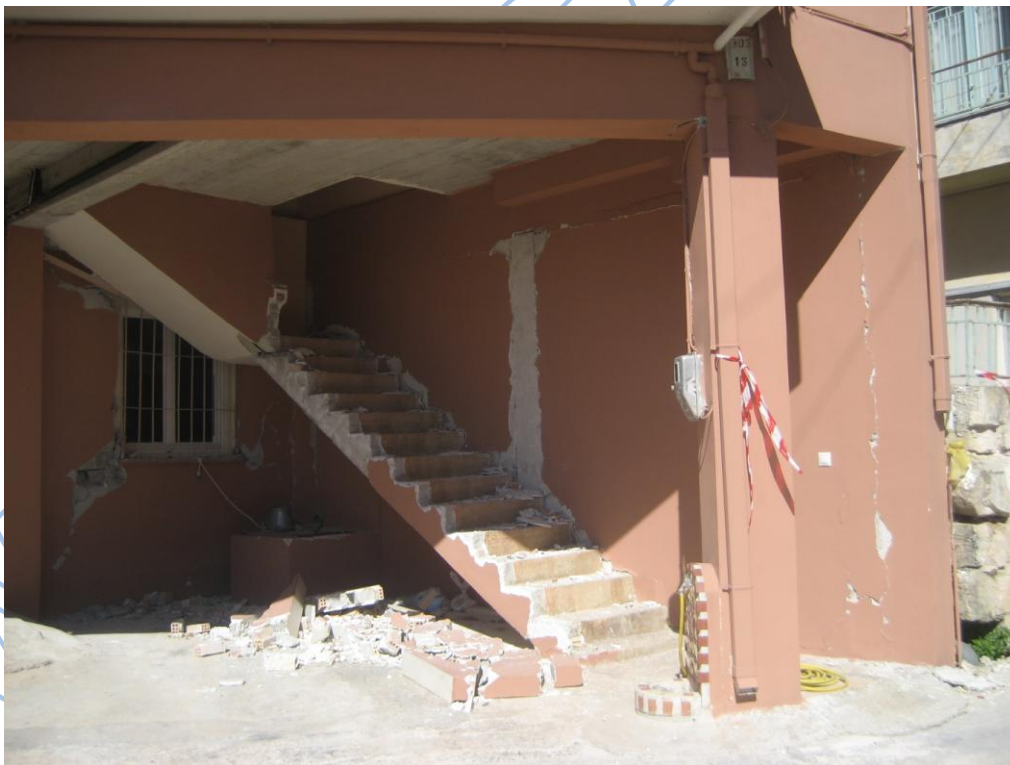
Photos 3.55, 3.56. Reinforced concrete building at the southern villages of Paliki peninsula as damaged during 26-1-2014 (up) and during 3-2-2014 (low) earthquakes.
