KEFALONIA EARTHQUAKE 26/1/2014 AND 3/2/2014

Technical Report · May 2014

STRONG GROUND MOTION OF THE FEBRUARY 3, 2014 (M6.0) CEPHALONIA EARTHQUAKE: EFFECTS ON SOIL AND BUILT ENVIRONMENT IN COMBINATION WITH THE JANUARY 26, 2014 (M6.1) EVENT

**T H E S S A L O N I K I
F E B R U A R Y 2 0 1 4**

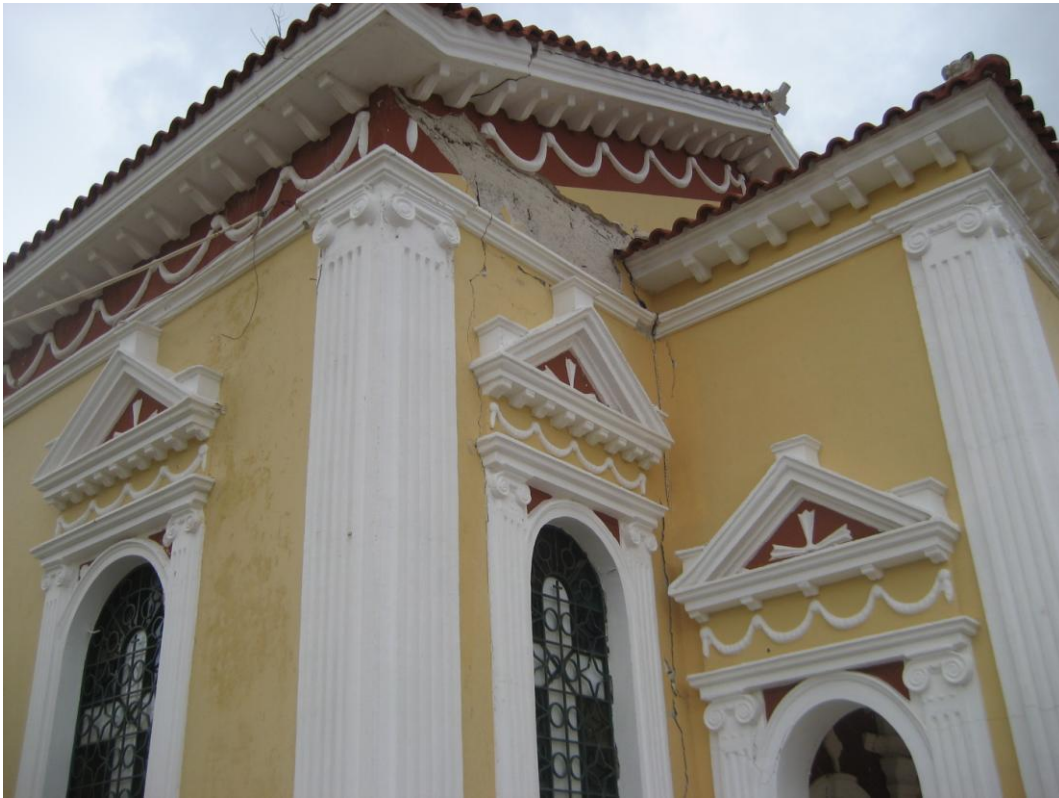
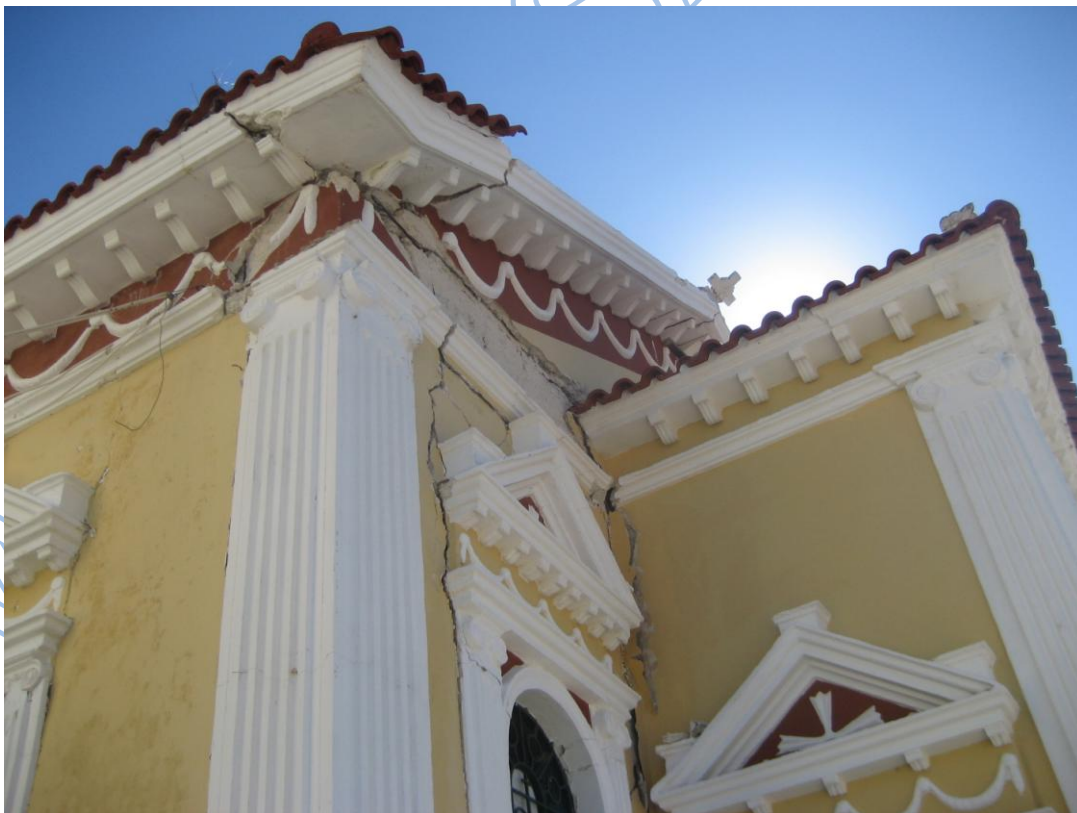
Photos 3.57, 3.58. Temple at the southern villages of Paliki peninsula as damaged during 26-1-2014 (up) and during 3-2-2014 (low) earthquakes.

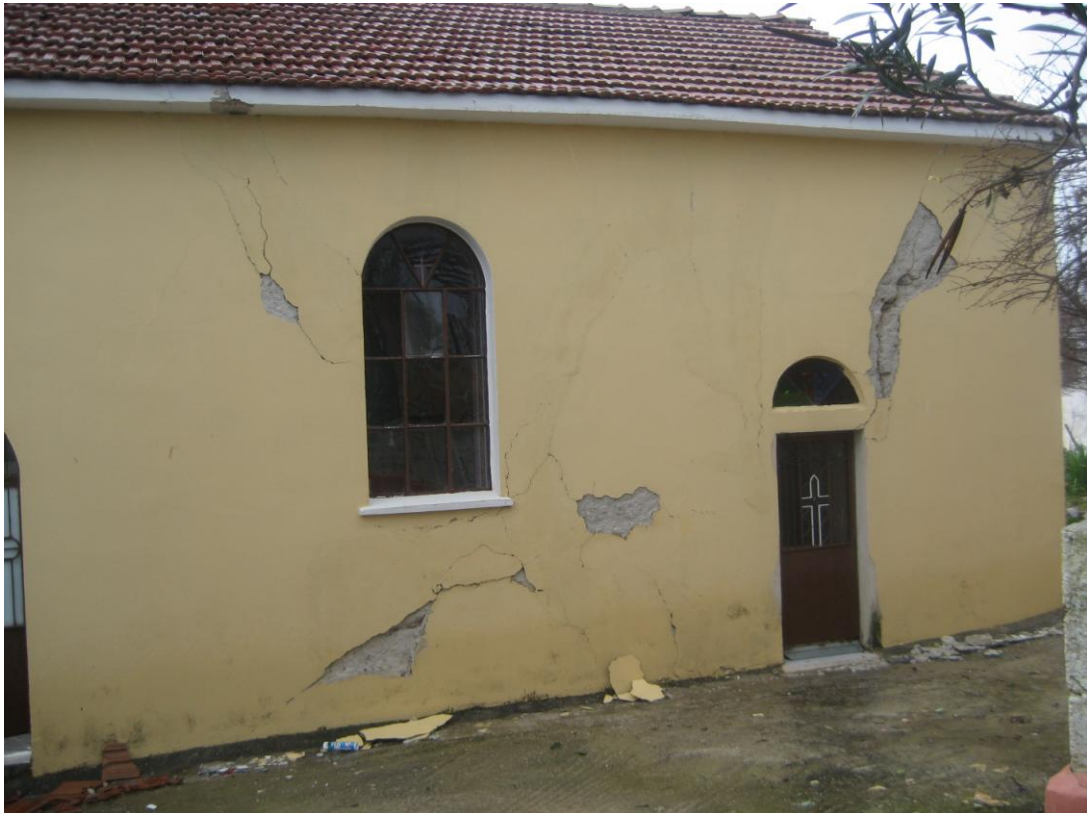
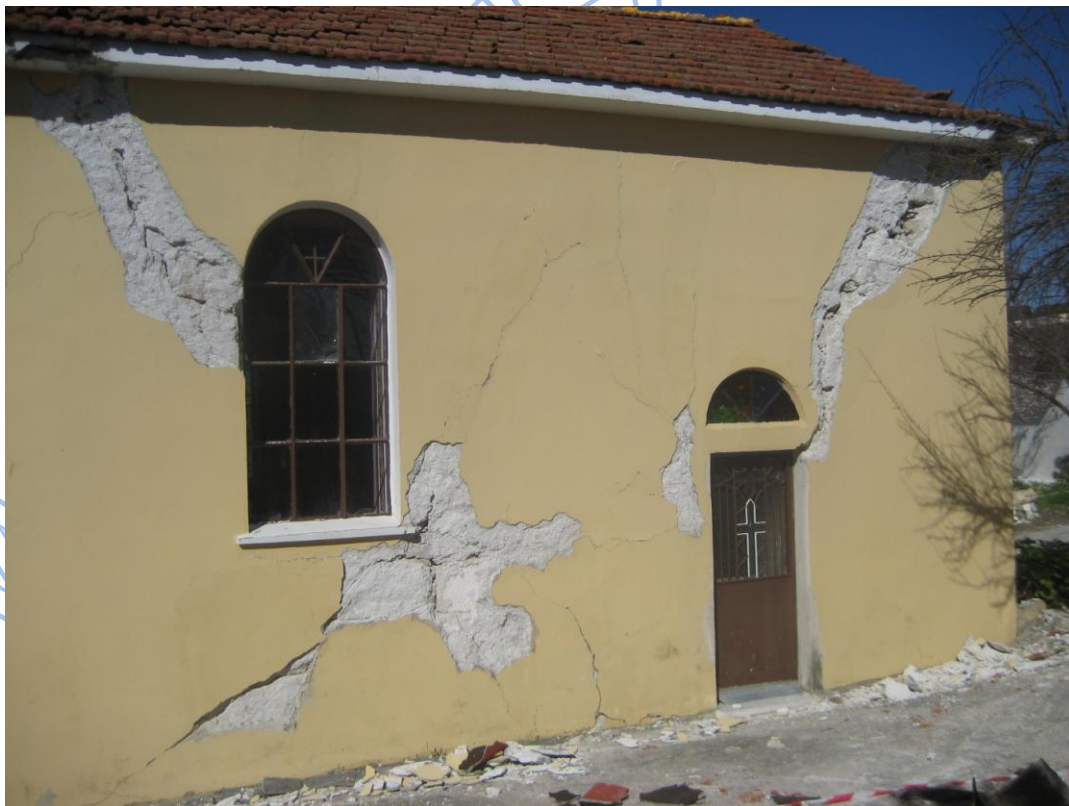
Photos 3.59, 3.60. Temple at the southern villages of Paliki peninsula as damaged during 26-1-2014 (up) and during 3-2-2014 (low) earthquakes.
