KEFALONIA EARTHQUAKE 26/1/2014 AND 3/2/2014

Technical Report · May 2014

STRONG GROUND MOTION OF THE FEBRUARY 3, 2014 (M6.0) CEPHALONIA EARTHQUAKE: EFFECTS ON SOIL AND BUILT ENVIRONMENT IN COMBINATION WITH THE JANUARY 26, 2014 (M6.1) EVENT

**T H E S S A L O N I K I
F E B R U A R Y 2 0 1 4**

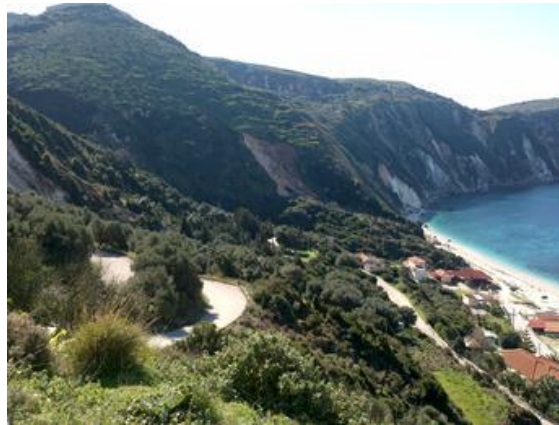
Many minor and major shallow rock failures were recorded at steep cliffs along the west coast of Paliki. The more pronounced of those seems to be several disaggregated slides with debris flow observed at the Petani shoreline (38.260941° N, 20.377410° E), inducing damage to the road (Figure 2.4). An extended rock slope type of failure (almost 250m long) was also recorded at a sandy marl escarpment in the shoreline of Xi area (from 38.159537° N,

Figure 2.4. Disaggregated slides with debris flow observed after the second earthquake of 03/02/2014 at Petani shoreline (38.260941° N, 20.377410° E).

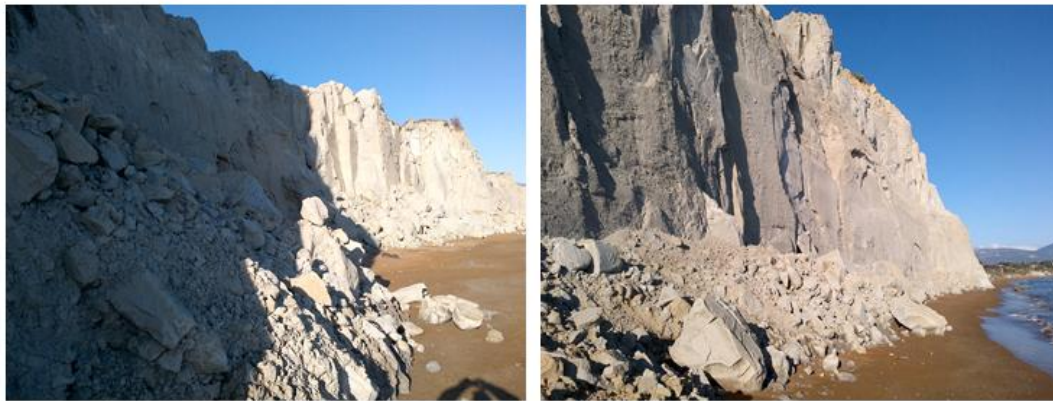
Figure 2.5. Shoreline of Xi area (from 38.159537° N, 20.410148° E to 38.160405° N, 20.413083° E) south of Paliki peninsula where an extended slide (almost 250m long) of a sandy marl escarpment was observed.

20.410148° E to 38.160405° N, 20.413083° E) south of Paliki peninsula (Figure 2.5). Rock slides in cracked limestone formations were also recorded at the northern part of Argostoli bay (38.287065° N, 20.448024° E). Evidently, the second earthquake contributed further to the evolution of the above rock slide as shown in Figure 2.6. Substantial rock slope failures were recorded in Myrtos Bay. On the east slope, two limestone blocks rolled down causing total damage to the road (38.337833°N, 20.532317°E). The above roll path is depicted in Figure 2.7.

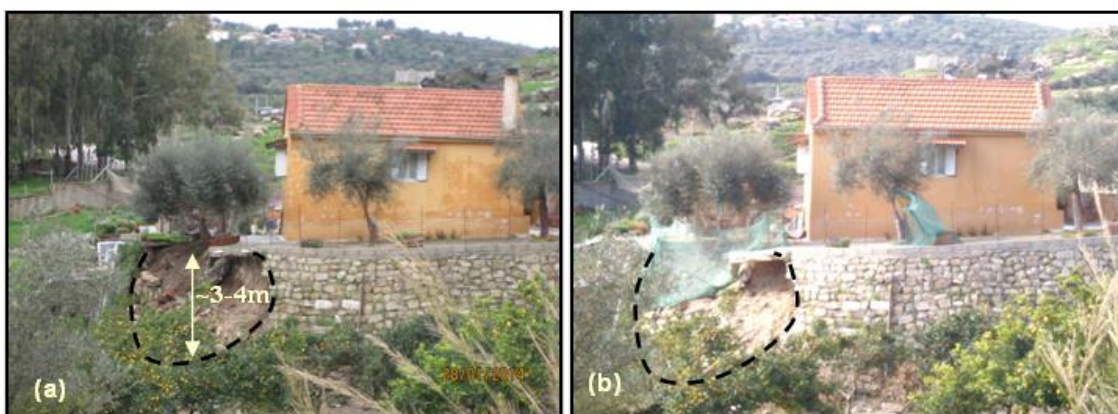
A similar type of failure was recorded after the first earthquake of 26/01/2014 at a stone masonry retaining wall of a physical slope upon which a single-storey building is founded (Figure 2.10). The above failure was recorded close to Kouvalata village (38.234484° N,

20.419554°E) and followed by a local landslide of the backfill. The observed failure was further deployed after the second earthquake of 03/02/2014 whereas heavy rainfall should also have contributed to the evolution of the landslide phenomena.

Figure 2.10. Single-storey building close to Kouvalata village (38.234484° N, 20.419554° E): (a) Failure of the stone masonry retaining wall followed by local landslide of the supporting foundation soil after the first earthquake of 26/01/2014, (b) Further deployment of the failure surface after the second earthquake of 03/02/2014.

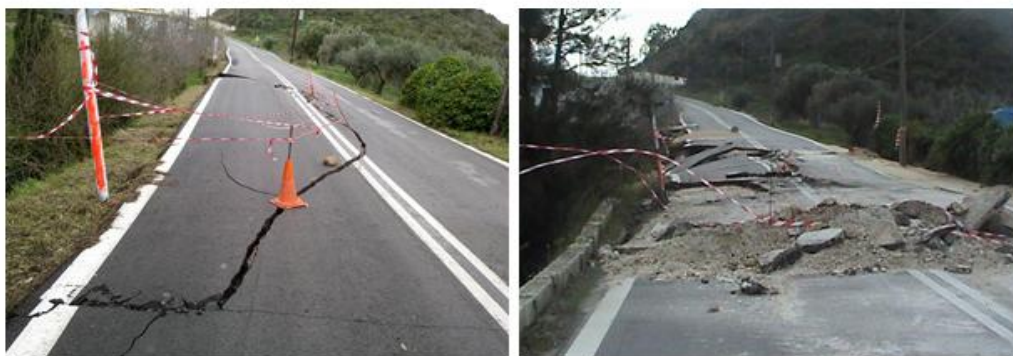
The circular type of embankment sliding observed after the first earthquake was further deployed inducing severe damage on the road after the second earthquake (Figure 2.12). Due to the particularly extensive damage the local authorities were forced to close down the road access.

Figure 2.12. Road connecting Chavriata and Vouni villages. Left: Circular type of sliding observed after the first earthquake. Right: Embankment failure after the second earthquake inducing total road damage.

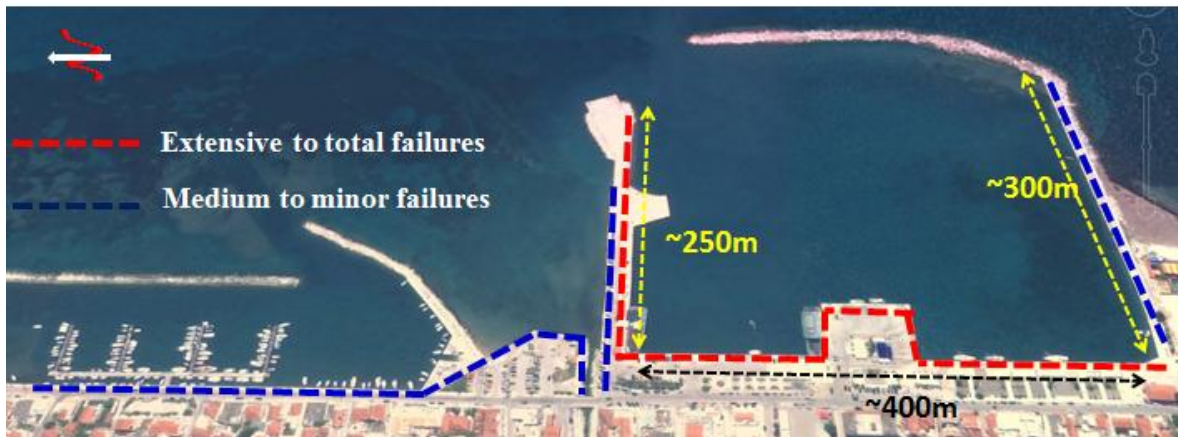
The second earthquake of 03/02/2014 induced severe failures at the port of Lixouri including important horizontal displacements and rotations of the quay walls, extensive cracks on the port jetties and major liquefaction *ejecta* followed by lateral spreading. The above type of failures was repeatedly observed along the 950m long main piers of Lixouri port (Figure 2.14). The severity of the induced failures is evident in Figure 2.15 showing the magnitude of relative displacement between two adjacent quay walls and settlement of the backfill recorded at the same point along the south part of the 250m main pier of Lixouri port due to lateral spreading. Interestingly, the north side of the same pier (shown in Figure 2.14 with a blue dashed line) remained practically intact after the second earthquake. A similar deformation pattern was observed at the old jetty of the above pier (Figure 2.16). The recorded displacement of the quay walls were recorded as high as 80cm.

Figure 2.14. General outline of the severity of damage induced by the second earthquake of 03/02/2014 at the main piers of Lixouri port.

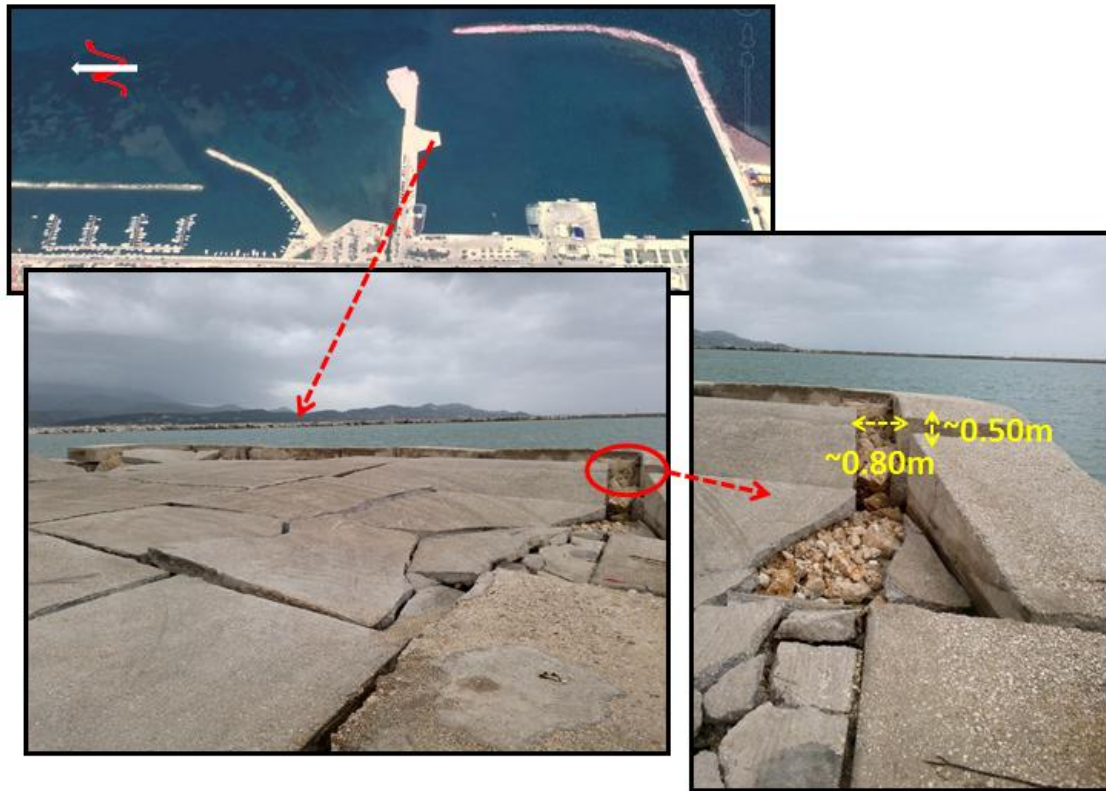
Figure 2.16. Extensive lateral spreading induced by the second earthquake on the 250m main pier of Lixouri port.

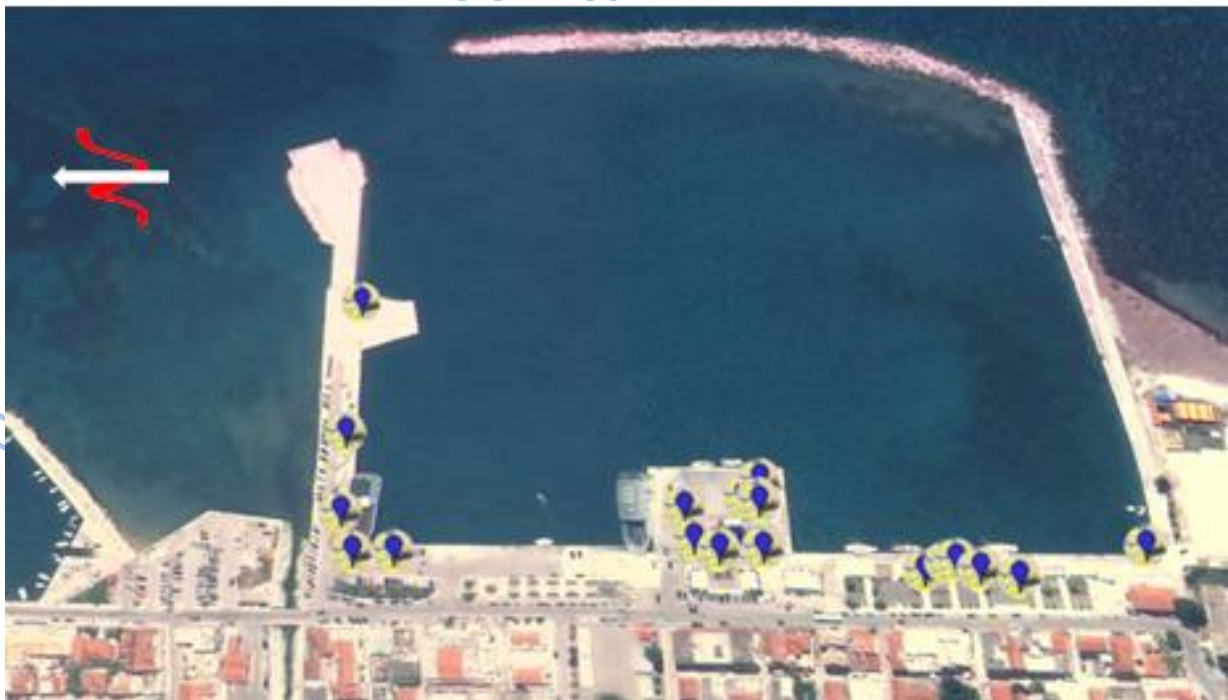
One of the main findings during reconnaissance of Lixouri port was the particularly extensive liquefaction *ejecta* recorded in several locations (Figure 2.17) ejecting gravel particles of significant size in some cases. Typical liquefaction *ejecta* are shown in Figure 2.18. It should be mentioned that liquefaction was mainly recorded after the second earthquake event. Substantially less extensive failures of the above type were recorded after the first earthquake

Figure 2.17. General outline of liquefaction traces recorded after the second earthquake along Lixouri port.

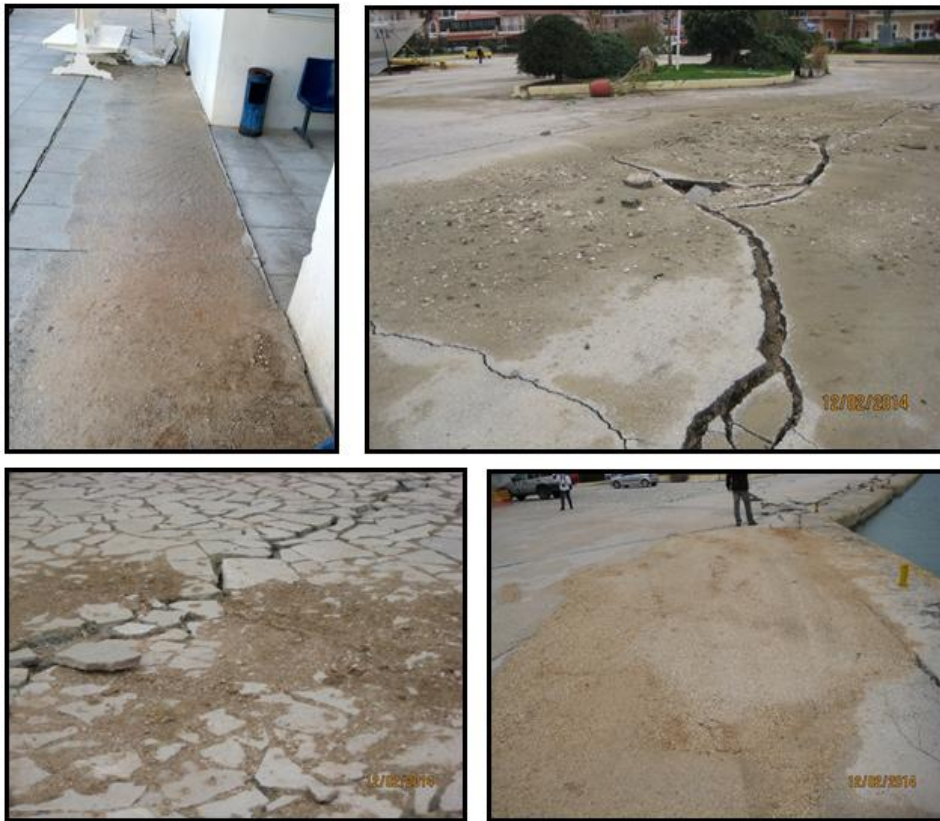
Figure 2.18. Typical liquefaction *ejecta* recorded along Lixouri port.

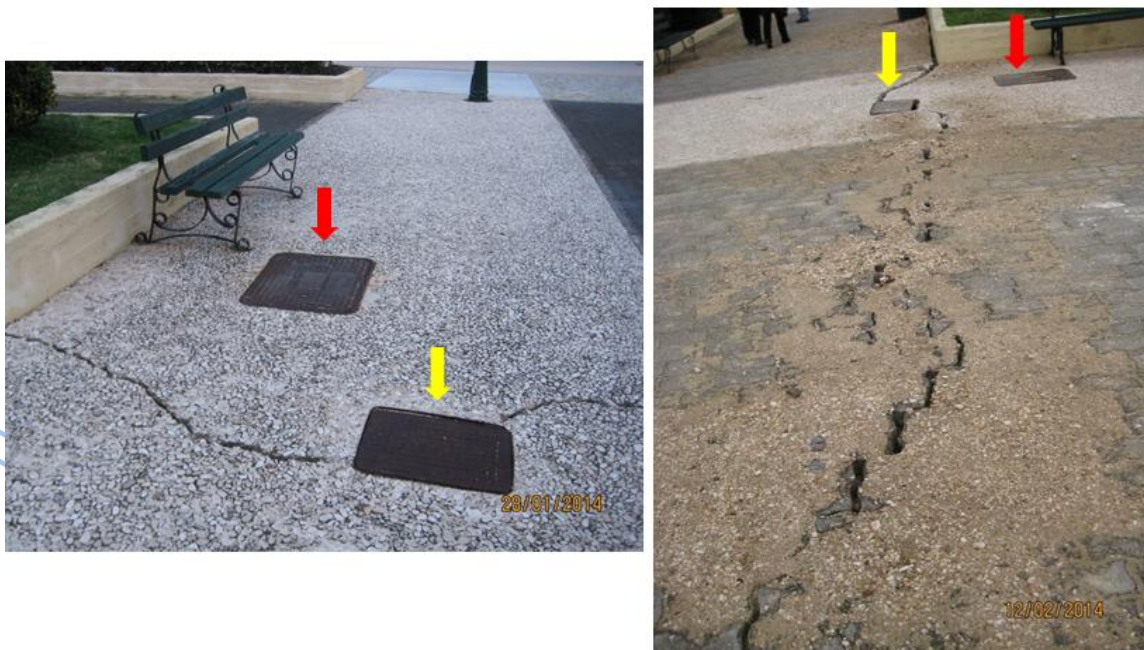
of 26/01/2014. In support to the above, Figure 2.19 compares two snapshots taken from a different angle at the same point of Lixouri port after the two successive major earthquakes. The difference between the effects of both earthquakes in terms of liquefaction *ejecta* is evident. With reference to quay walls, deformations and settlements of the backfill a similar difference was recorded (Figure 2.20) between the two earthquakes indicating the severity of the second one.

Figure 2.19. Indicative case of the extensive liquefaction *ejecta* induced by the second earthquake of 03/02/2014 (right) compared to the first earthquake of 26/01/2014. Photos taken at the same point form a different angle.

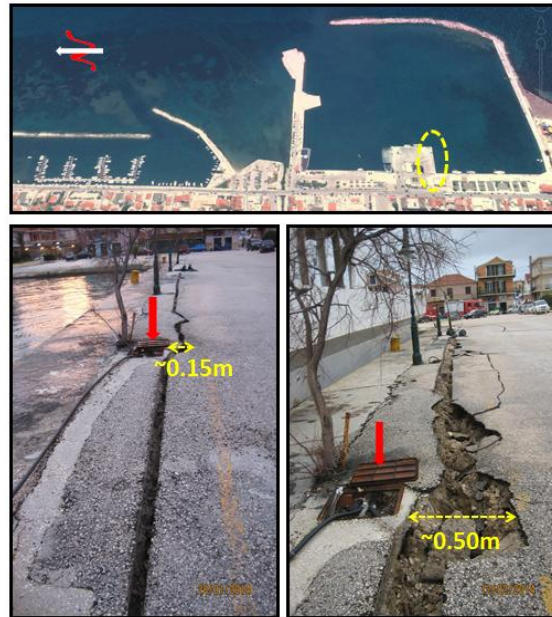
Figure 2.20. Performance of a typical quay wall at Lixouri port after the first (left) and second (right) earthquake. The evolution of lateral displacement is evident denoting the severe damage induced by the second earthquake of 03/02/2104.

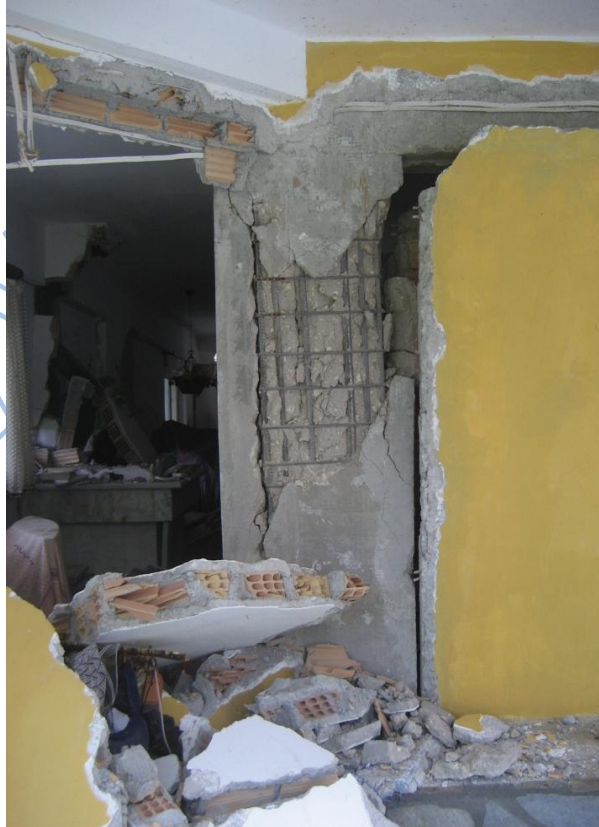
Photos 3.13, 3.14. Three storey building severely damaged in Livadi. Total collapse of

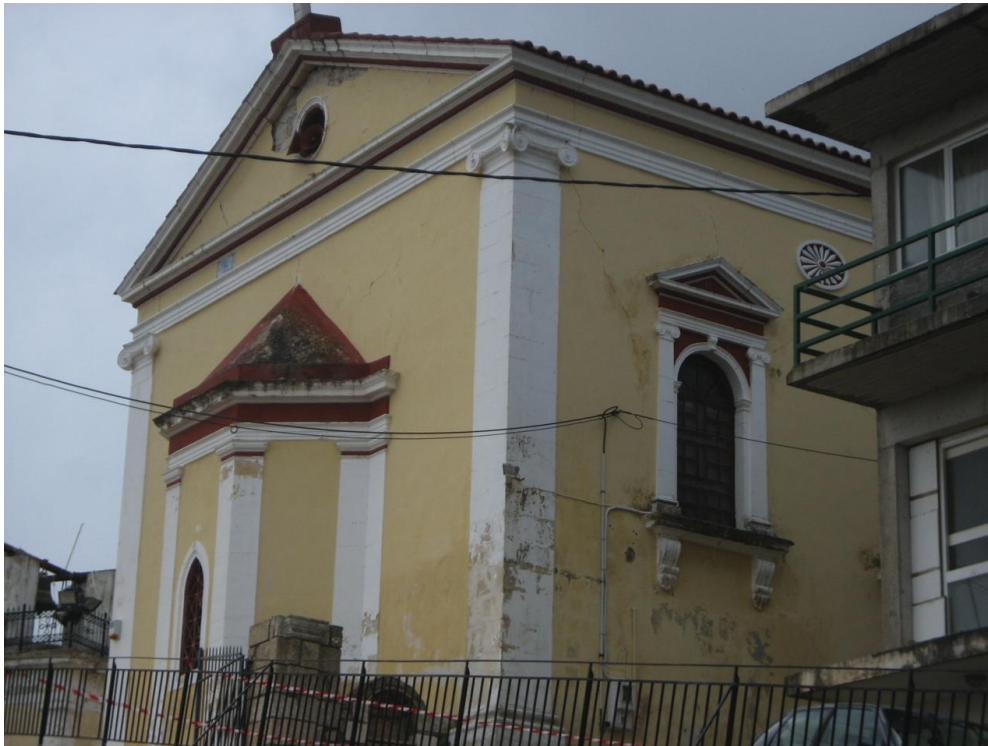
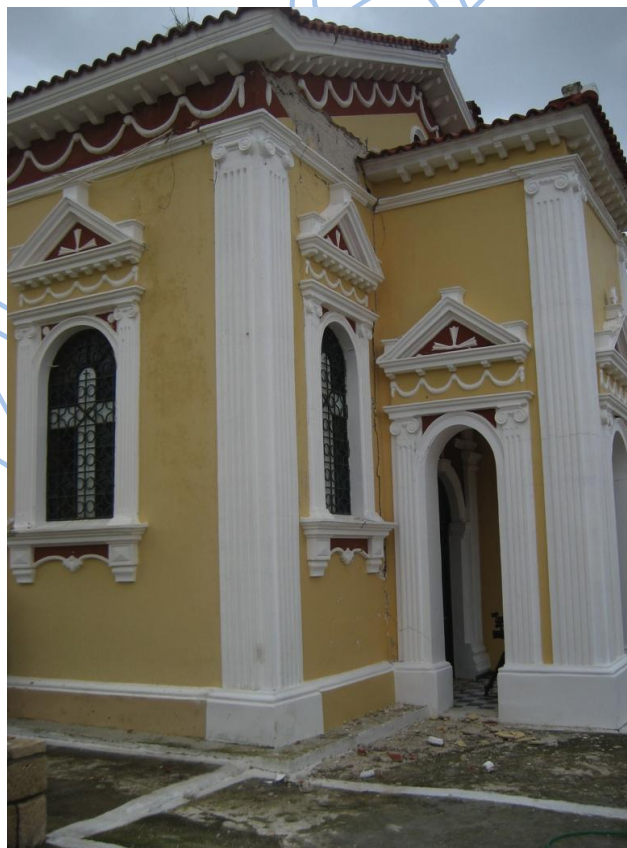
Photos 3.19, 3.20. Two temples at the southern area close to Lixouri.

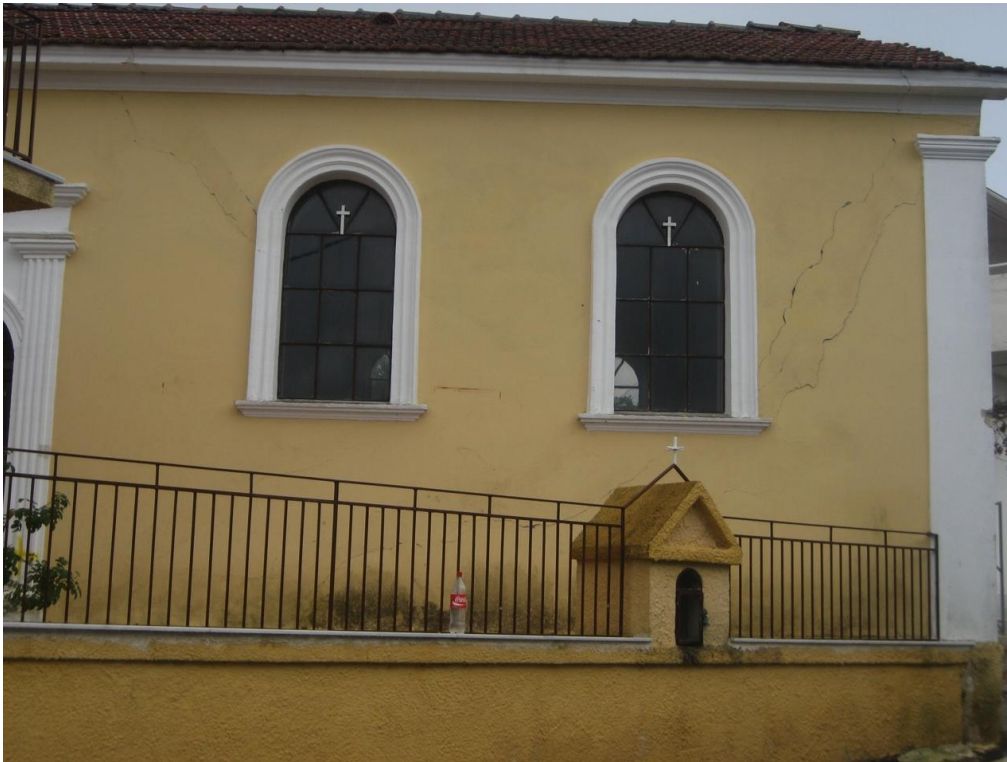
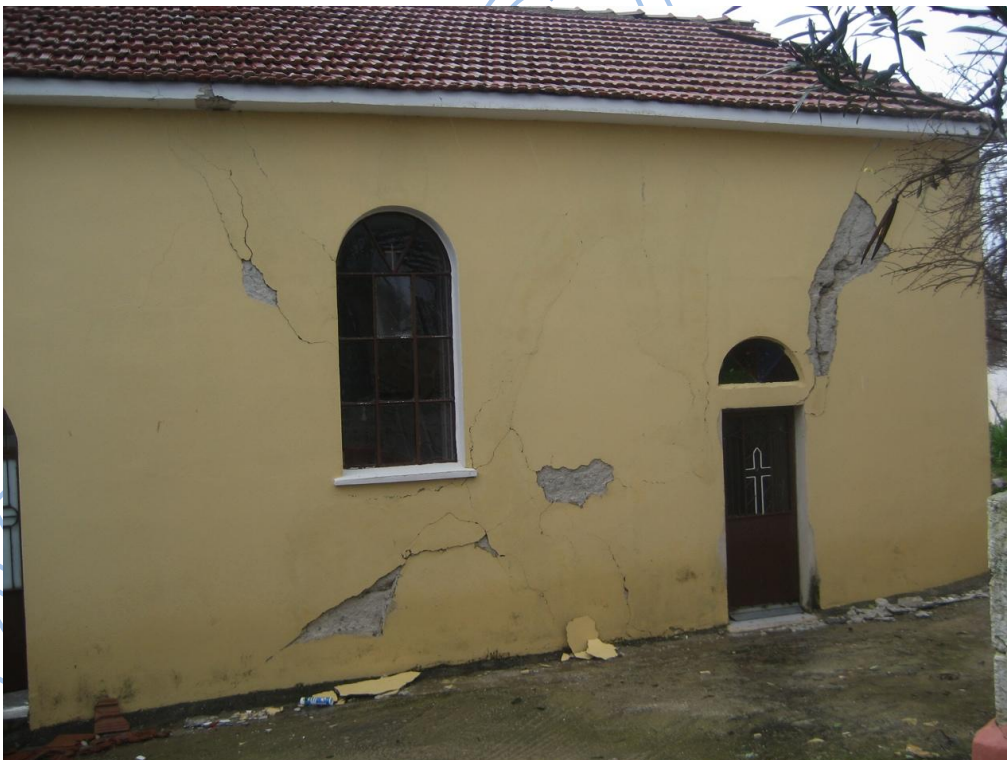
Photos 3.21, 3.22. Temple at the southern area close to Lixouri.

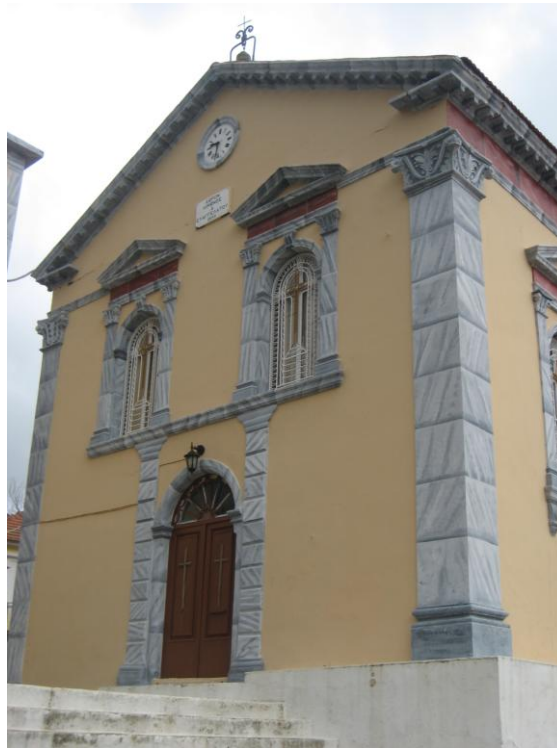
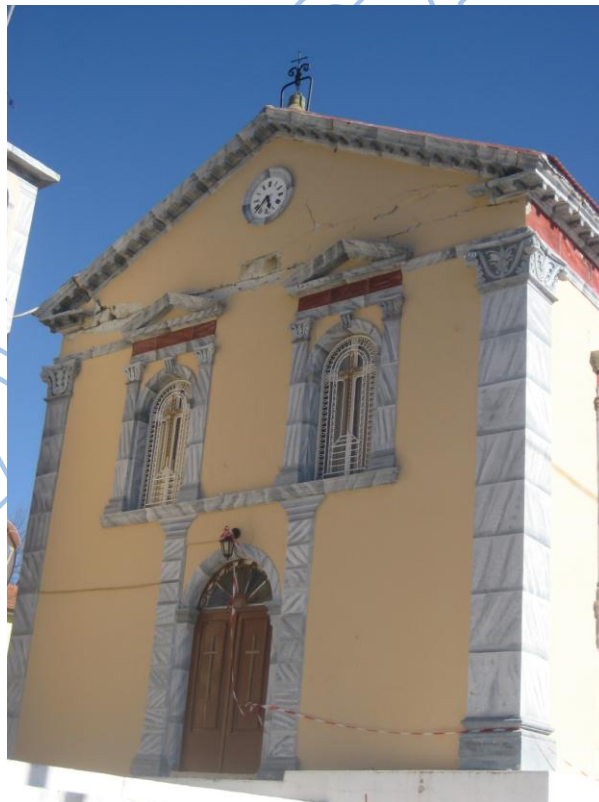
Photos 3.51, 3.52. Temple at the northern villages of Paliki peninsula as damaged during 26-1-2014 (up) and during 3-2-2014 (low) earthquakes.
